# Access Compliance Report Public Rights-of-Way (Curb Ramps)

Main Street: NEWPORT\_BLVD Cross Street: COWAN\_HEIGHTS\_DR Location: SE

ADA ID: RPRK211012152507 Ramp Type: Type 1 - Perpendicular Diagonal Initial Pass/Fail: Pass Overall Compliance: No Severity Score: 0

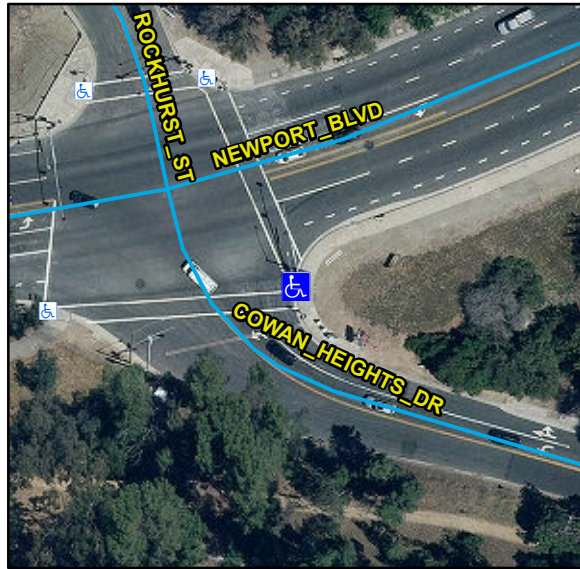
| Compliance | Description | Data | Compliance | Description | Data |
|---|---|---|---|---|---|
| Yes | Gutter Ponding | No | No | Curb Slope | 9.7 |

Remove & Replace Curb Slope.

R304.2.2, STD 1115
