# Access Compliance Report Public Rights-of-Way (Curb Ramps)

Main Street: COWAN\_HEIGHTS\_DR Cross Street: NEWPORT\_BLVD Location: SW

ADA ID: RPRK211012153148 Ramp Type: Type 1 - Perpendicular Diagonal Initial Pass/Fail: Pass Overall Compliance: No Severity Score: 6

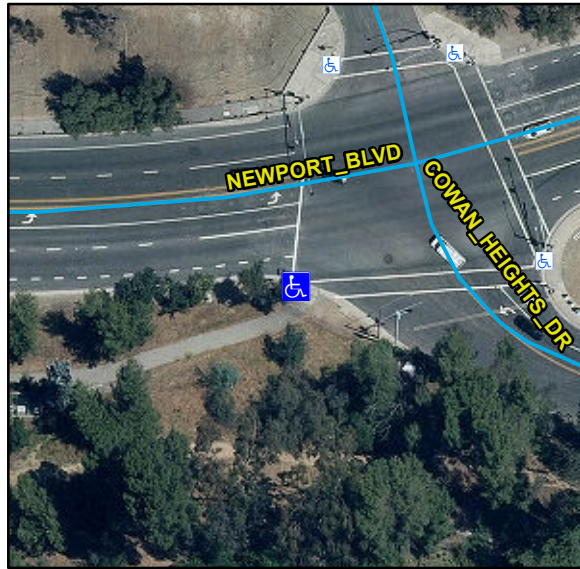
| Compliance | Description | Data | Compliance | Description | Data |
|---|---|---|---|---|---|
| No | Landing Run Slope (%) | 8 | N/A | Flare Traversable RT | Yes |
| Yes | Gutter Ponding | No | No | Curb Slope | 7.2 |

Remove & Replace Curb Ramp With Two New Directional Ramps or Equivalent.

R304.2.2, R304.2.2-Perp, R304.3.2-Para, STD 1115
