# Access Compliance Report Public Rights-of-Way (Curb Ramps)

Main Street: CRAWFORD\_CANYON\_RD Cross Street: NEWPORT\_BLVD Location: NE

ADA ID: RPRK211012171622 Ramp Type: Type 1 - Perpendicular Diagonal Initial Pass/Fail: Fail Overall Compliance: No Severity Score: 2

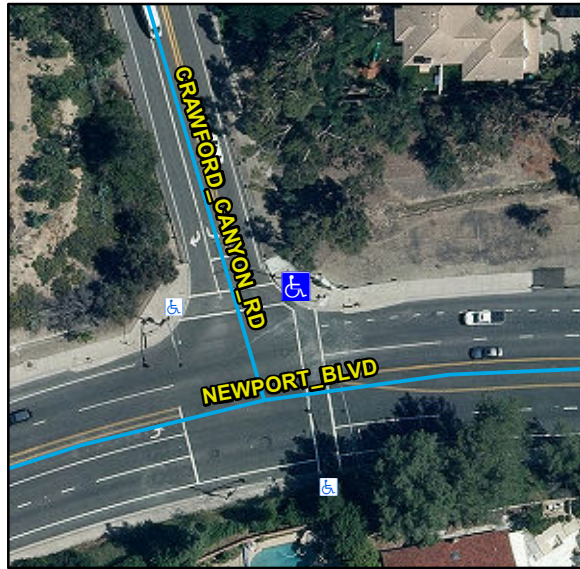
| Compliance | Description | Data | Compliance | Description | Data |
|---|---|---|---|---|---|
| No | Ramp Cross Slope (%) | 4.1 | N/A | Flare Traversable LT | N/A |
| No | Gutter Lip Height (in) | 0.25 | | Road Run Slope (%) | 0 |

Remove & Replace Curb Ramp With Two New Directional Ramps or Equivalent. Grind Gutter Lip.
