Access Compliance Report Public Rights-of-Way (Curb Ramps)

Main Street: NEWPORT_BLV D **Cross Street:** CRAWFORD_CANYON_RD **Location:** SE

ADA ID: RPRK211012171951 **Ramp Type:** Type 4 - Parallel **Initial Pass/Fail:** Fail **Overall Compliance:** No **Severity Score:** 45

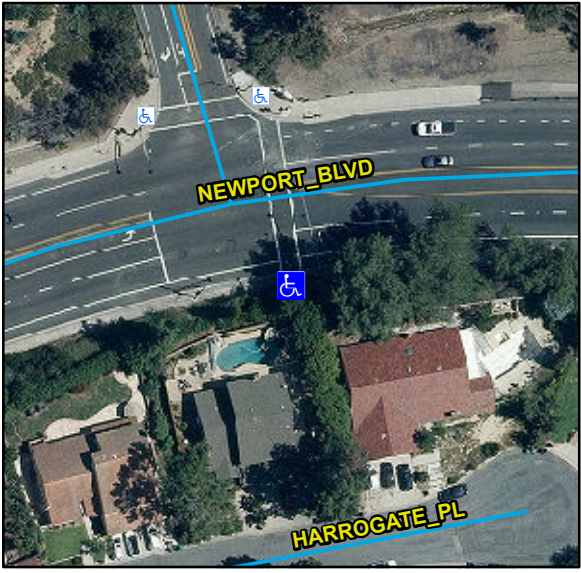
Compliance	Description	Data	Compliance	Description	Data
N/A	Ramp Length LT (in)	62	N/A	Ramp Length RT (in)	61
Yes	Ramp Width LT (in)	90	Yes	Ramp Width RT (in)	90
No	Ramp Run Slope LT (%)	15.5	Yes	Ramp Run Slope RT (%)	0.2
No	Ramp Cross Slope LT (%)	5.3	No	Ramp Cross Slope RT (%)	5.9
N/A	Landing Present	N/A	N/A	DWS Provided	N/A
N/A	Landing Length (in)	N/A	N/A	DWS Contrast	N/A
N/A	Landing Width (in)	N/A	N/A	DWS Length (in)	N/A
N/A	Landing Run Slope (%)	N/A	N/A	DWS Full Width	N/A
N/A	Landing Cross Slope (%)	N/A		DWS Offset Type	N/A
N/A	Landing Movement Obstructed?	N/A	N/A	DWS Offset Left (in)	N/A
	Landing Movement Type	N/A	N/A	DWS Offset Right (in)	N/A
N/A	Landing Shared	N/A			
N/A	Clear Space	N/A			
N/A	Clear Space To Crosswalk (in)	N/A			
N/A	Marked Crosswalk 1	Yes	N/A	Marked Crosswalk 2	N/A
	Crossing 1 Direction	N		Crossing 2 Direction	N/A
N/A	Marked Crosswalk 1 Width (in)	144		Marked Crosswalk 2 Width (in)	N/A

N/A	Ramp Inside Crosswalk 1	Yes	N/A	Ramp Inside Crosswalk 2	N/A
	Crossing 1 Slope (%)	2.8		Crossing 2 Slope (%)	N/A
	Crossing 1 Cross Slope (%)	9.8		Crossing 2 Cross Slope (%)	N/A
N/A	Gutter Ponding	N/A	N/A	Curb Slope	6.2
No	Gutter Lip Height (in)	0.25		Road Run Slope (%)	N/A
N/A	Gutter Run Slope (%)	N/A		Road Cross Slope (%)	N/A
N/A	Gutter Cross Slope (%)	N/A	No	Perpendicular Joint Present	No
Yes	Overall Surface Condition	Acceptable		Spandrel Present?	No
	Cross Gutter Present?	No		Replace Spandrel?	N/A
	Replace Cross Gutter?	N/A

Possible Solutions:
Remove & Replace Entire Ramp. Grind Gutter Lip.

OC Std/PROW:
 R204.3, R304.3.2, R304.5.3, R302.7.2, STD 1115
