# Access Compliance Report Public Rights-of-Way (Curb Ramps)

| Main Street: NEWPORT_BLVD | | Cross Street: CRAWFORD_CANYON_RD | | Location: | NW |
| ADA ID: RPRK211012172418 | Ramp Type:Type 1 - Perpendicular Diagonal Initial Pass/Fail: Fail | | Overall Compliance: No | Severity Score: | 45 |

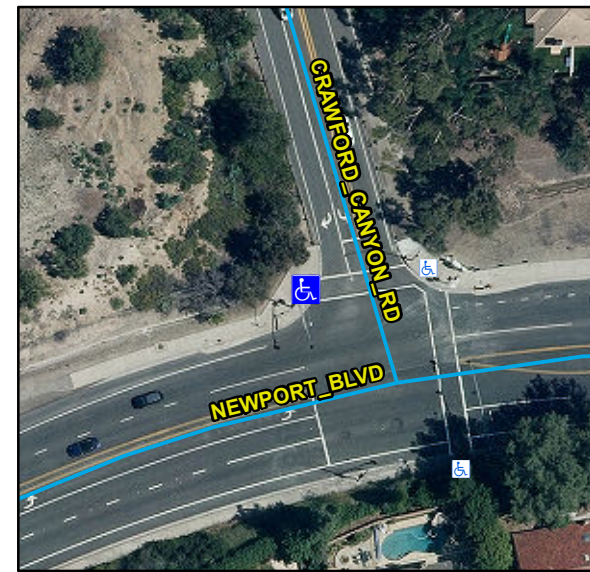
| Compliance | Description | Data | Compliance | Description | Data |
|---|---|---|---|---|---|
| No | Ramp Run Slope (%) | 8.5 | N/A | Flare Slope LT (%) | N/A |
| No | Ramp Cross Slope (%) | 7.1 | N/A | Flare Traversable LT | N/A |
| No | Gutter Lip Height (in) | 0.25 | | Road Run Slope (%) | 7.4 |

**Remove & Replace Curb Ramp With Two New Directional Ramps or Equivalent. Restripe Crosswalk.**

**R304.2.2, R204.3, R304.5.3, R302.7.2, STD 1115**
