Access Compliance Report Public Rights-of-Way (Curb Ramps)

Main Street: MARCY_RANCH_RD **Cross Street:** MARCY_DR **Location:** E

ADA ID: RPRK211012173149 **Ramp Type:** Type 1 - Perpendicular Diagonal Initial Pass/Fail: Fail **Overall Compliance:** No **Severity Score:** 60

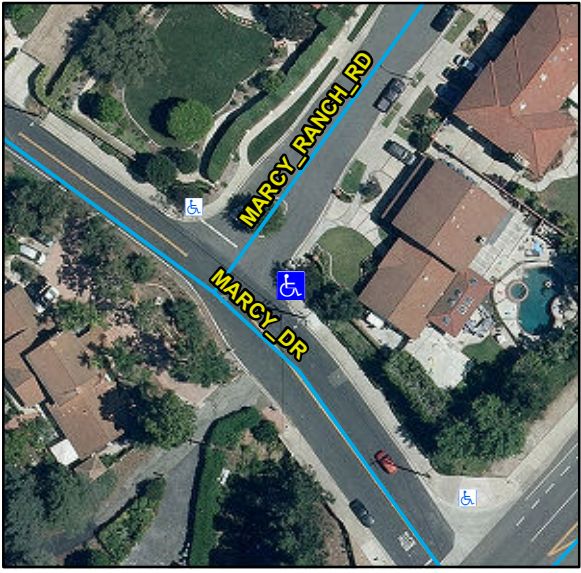
Compliance	Description	Data	Compliance	Description	Data
N/A	Ramp Length (in)	69	N/A	Flare Type LT	
Yes	Ramp Width (in)	48			N/A
No	Ramp Run Slope (%)	15	N/A	Flare Slope LT (%)	N/A
No	Ramp Cross Slope (%)	10.8	N/A	Flare Traversable LT	N/A
N/A	Landing Present	N/A	N/A	Flare Type RT	
N/A	Landing Length (in)	N/A			N/A
N/A	Landing Width (in)	N/A	N/A	Flare Slope RT (%)	N/A
N/A	Landing Run Slope (%)	N/A	N/A	Flare Traversable RT	N/A
N/A	Landing Cross Slope (%)	N/A	N/A	DWS Provided	N/A
N/A	Landing Movement Obstructed?	N/A	N/A	DWS Contrast	N/A
	Landing Movement Type	N/A	N/A	DWS Length (in)	N/A
N/A	Landing Shared	N/A	N/A	DWS Full Width	N/A
N/A	Clear Space	Yes	N/A	DWS Offset Left (in)	N/A
N/A	Clear Space To Crosswalk (in)	N/A	N/A	DWS Offset Right (in)	N/A
N/A	Marked Crosswalk 1	No	N/A	Marked Crosswalk 2	No
	Crossing 1 Direction	NW		Crossing 2 Direction	SW
	Marked Crosswalk 1 Width (in)	N/A		Marked Crosswalk 2 Width (in)	N/A

N/A	Ramp Inside Crosswalk 1	N/A	Yes	Ramp Inside Crosswalk 2	N/A
	Crossing 1 Slope (%)	7.7		Crossing 2 Slope (%)	3.2
	Crossing 1 Cross Slope (%)	6.8		Crossing 2 Cross Slope (%)	7
N/A	Gutter Ponding	N/A	N/A	Curb Slope	2.2
No	Gutter Lip Height (in)	0.25		Road Run Slope (%)	8.3
N/A	Gutter Run Slope (%)	N/A		Road Cross Slope (%)	3.6
N/A	Gutter Cross Slope (%)	N/A			
Yes	Overall Surface Condition: Acceptable		No	Perp Joint Present	No
	Cross Gutter Present?	No		Spandrel Present?	No
	Replace Cross Gutter?	N/A		Replace Spandrel?	N/A

Possible Solutions:
Remove & Replace Curb Ramp With Two New Directional Ramps or Equivalent. Grind Gutter Lip.

OC Std/PROW:
 R204.3, R304.2.2, R304.5.3, R302.7.2, STD 1115
