# Access Compliance Report Public Rights-of-Way (Curb Ramps)

Main Street: MARCY\_RANCH\_RD Cross Street: MARCY\_DR Location: NE

ADA ID: RPRK211012173508 Ramp Type: Type 1 - Perpendicular Diagonal Initial Pass/Fail: Fail Overall Compliance: No Severity Score: 16

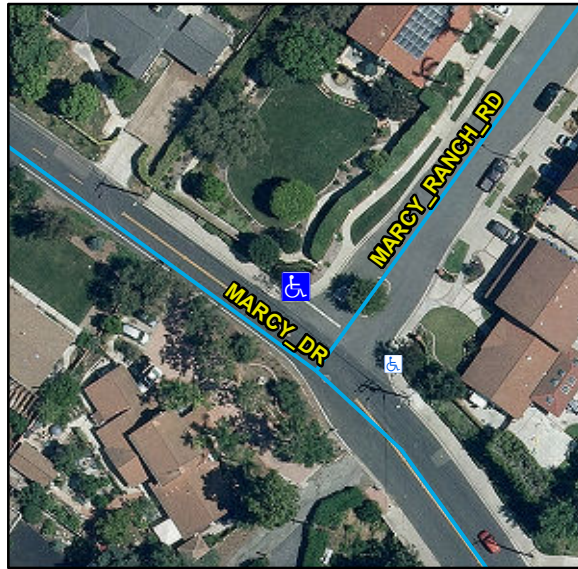
| Compliance | Description | Data | Compliance | Description | Data |
|---|---|---|---|---|---|
| No | Ramp Run Slope (%) | 9.9 | N/A | Flare Slope LT (%) | N/A |
| No | Ramp Cross Slope (%) | 4.3 | N/A | Flare Traversable LT | N/A |
| No | Gutter Lip Height (in) | 0.25 | | Road Run Slope (%) | 3.3 |

Remove & Replace Curb Ramp With Two New Directional Ramps or Equivalent.
