# Access Compliance Report Public Rights-of-Way (Curb Ramps)

Main Street: MARCY\_RANCH\_RD Cross Street: MARCY\_DR Location: NE

ADA ID: RPRK211012173650 Ramp Type: Type 1 - Perpendicular Diagonal Initial Pass/Fail: Pass Overall Compliance: No Severity Score: 9

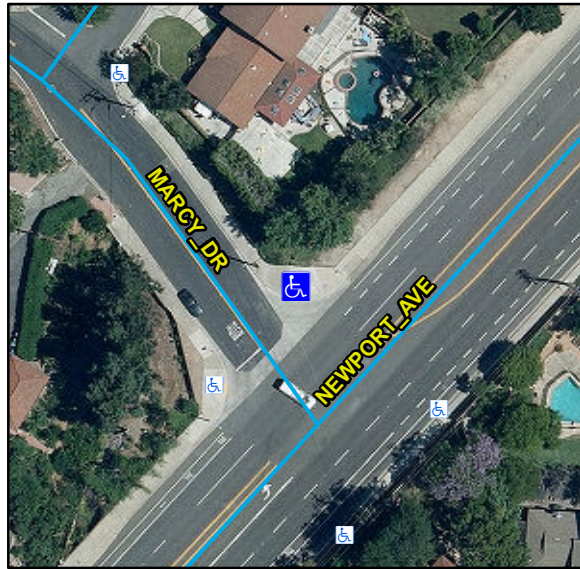
| Compliance | Description | Data | Compliance | Description | Data |
|---|---|---|---|---|---|
| Yes | Gutter Ponding | No | No | Curb Slope | 10.4 |
| No | Gutter Run Slope (%) | 5.8 | | Road Cross Slope (%) | 3.5 |

Remove & Replace Curb Ramp With Two New Directional Ramps or Equivalent. Remove & Replace Gutter.
