# Access Compliance Report Public Rights-of-Way (Curb Ramps)

| Main Street: MARCY_RANCH_RD | Cross Street: MARCY_DR | Location: NW |

| ADA ID: RPRK211012174022 | Ramp Type: Type 1 - Perpendicular Diagonal Initial Pass/Fail: Fail | Overall Compliance: No | Severity Score: 2 |

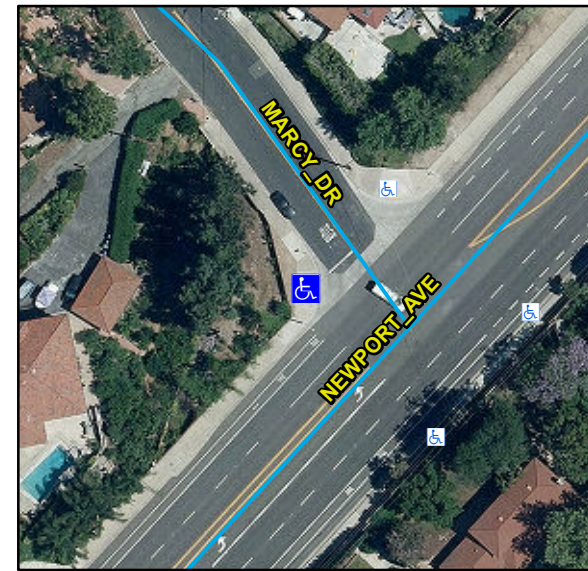
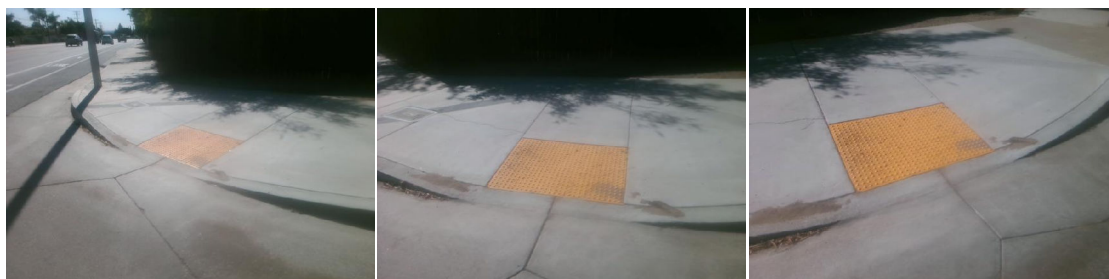
| Compliance | Description | Data | Compliance | Description | Data |
|---|---|---|---|---|---|
| No | Ramp Cross Slope (%) | 4.2 | N/A | Flare Traversable LT | N/A |
| N/A | Gutter Ponding | N/A | No | Curb Slope | 9.5 |

**Remove & Replace Curb Ramp With Two New Directional Ramps or Equivalent.**

**R304.2.2, R204.3, R304.5.3, STD 1115**

Total Cost: \$ 6160
