# Access Compliance Report Public Rights-of-Way (Curb Ramps)

Main Street: NEWPORT\_AVE Cross Street: HYDR\_PARK\_DR Location: SE

ADA ID: RPRK211012174452 Ramp Type: Type 4 - Parallel Initial Pass/Fail: Fail Overall Compliance: No Severity Score: 2

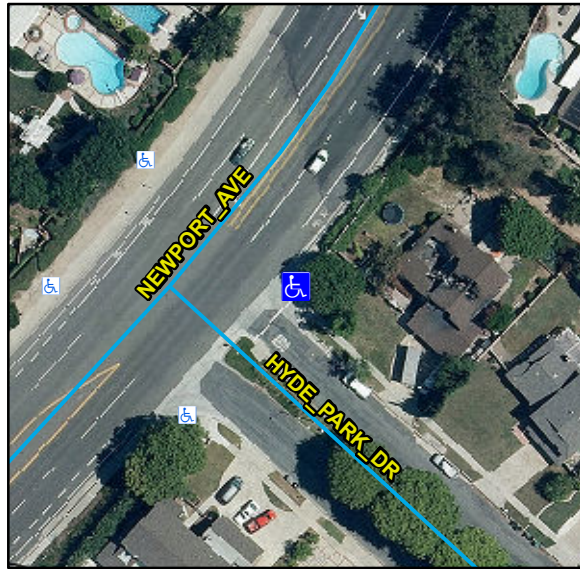
| Compliance | Description | Data | Compliance | Description | Data |
|---|---|---|---|---|---|
| No | Ramp Cross Slope LT (%) | 2.3 | Yes | Ramp Cross Slope RT (%) | 1 |

**Remove & Replace Curb Ramp With Two New Directional Ramps or Equivalent.**

**R304.5.3, STD 1115**
