# Access Compliance Report Public Rights-of-Way (Curb Ramps)

Main Street: HYDR\_PARK\_DR Cross Street: NEWPORT\_AVE Location: SW

ADA ID: RPRK211012174753 Ramp Type: Type 4 - Parallel Initial Pass/Fail: Fail Overall Compliance: No Severity Score: 2

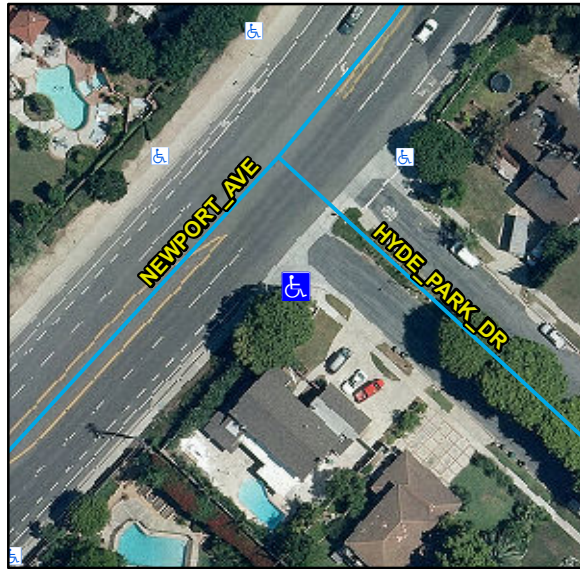
| Compliance | Description | Data | Compliance | Description | Data |
|---|---|---|---|---|---|
| No | Ramp Cross Slope LT (%) | 2.2 | Yes | Ramp Cross Slope RT (%) | 0.2 |

**Remove & Replace Curb Ramp With Two New Directional Ramps or Equivalent.**

**R304.5.3, STD 1115**
