# Access Compliance Report Public Rights-of-Way (Curb Ramps)

Main Street: FLAMINIAN\_WAY Cross Street: PINCIAN\_WAY Location: SW

ADA ID: RPRK211012180553 Ramp Type: Type 4 - Parallel Initial Pass/Fail: Fail Overall Compliance: No Severity Score: 15

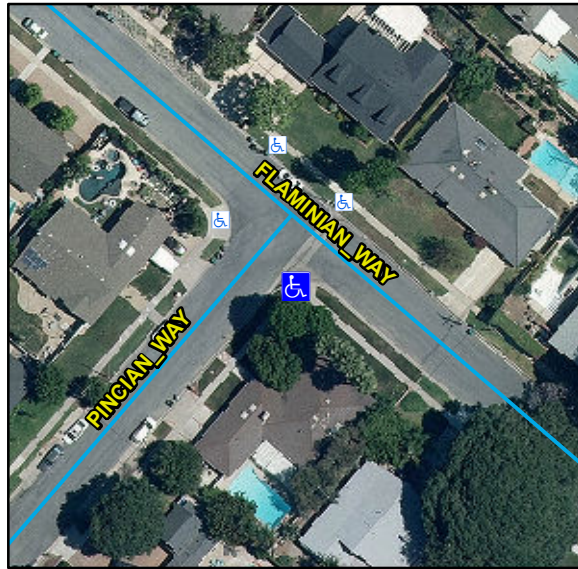
| Compliance | Description | Data | Compliance | Description | Data |
|---|---|---|---|---|---|
| No | Ramp Cross Slope LT (%) | 6.3 | No | Ramp Cross Slope RT (%) | 5.5 |
| N/A | Gutter Ponding | N/A | No | Curb Slope | 9.8 |

**Remove & Replace Curb Ramp With Two New Directional Ramps or Equivalent.**

**R304.2.2, R204.3, R304.5.3, STD 1115**
