Access Compliance Report Public Rights-of-Way (Curb Ramps)

Main Street: PINCIAN_WAY **Cross Street:** FLAMINIAN_WAY **Location:** NW

ADA ID: RPRK211012180924 **Ramp Type:** Type 4 - Parallel **Initial Pass/Fail:** Fail **Overall Compliance:** No **Severity Score:** 15

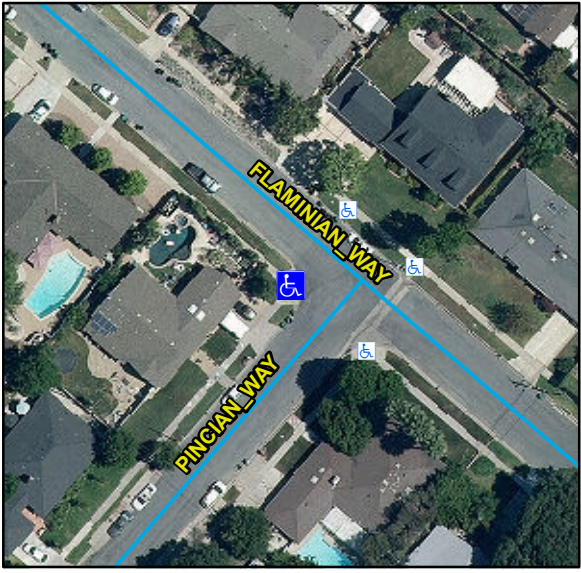
Compliance	Description	Data	Compliance	Description	Data
N/A	Ramp Length LT (in)	130	N/A	Ramp Length RT (in)	128
Yes	Ramp Width LT (in)	134	Yes	Ramp Width RT (in)	131
Yes	Ramp Run Slope LT (%)	0.2	Yes	Ramp Run Slope RT (%)	5.6
No	Ramp Cross Slope LT (%)	5.2	No	Ramp Cross Slope RT (%)	5.6
N/A	Landing Present	N/A	N/A	DWS Provided	N/A
N/A	Landing Length (in)	N/A	N/A	DWS Contrast	N/A
N/A	Landing Width (in)	N/A	N/A	DWS Length (in)	N/A
N/A	Landing Run Slope (%)	N/A	N/A	DWS Full Width	N/A
N/A	Landing Cross Slope (%)	N/A		DWS Offset Type	N/A
N/A	Landing Movement Obstructed?	N/A	N/A	DWS Offset Left (in)	N/A
	Landing Movement Type	N/A	N/A	DWS Offset Right (in)	N/A
N/A	Landing Shared	N/A			
N/A	Clear Space	Yes			
N/A	Clear Space To Crosswalk (in)	N/A			
N/A	Marked Crosswalk 1	No	N/A	Marked Crosswalk 2	No
	Crossing 1 Direction	SE		Crossing 2 Direction	NE
N/A	Marked Crosswalk 1 Width (in)	N/A	N/A	Marked Crosswalk 2 Width (in)	N/A

N/A	Ramp Inside Crosswalk 1	N/A	N/A	Ramp Inside Crosswalk 2	N/A
	Crossing 1 Slope (%)	7.5		Crossing 2 Slope (%)	5.6
	Crossing 1 Cross Slope (%)	1.6		Crossing 2 Cross Slope (%)	0.7
N/A	Gutter Ponding	N/A	N/A	Curb Slope	7.1
Yes	Gutter Lip Height (in)	0		Road Run Slope (%)	1.9
N/A	Gutter Run Slope (%)	N/A		Road Cross Slope (%)	8
N/A	Gutter Cross Slope (%)	N/A	No	Perpendicular Joint Present	No
Yes	Overall Surface Condition	Acceptable		Spandrel Present?	No
	Cross Gutter Present?	No		Replace Spandrel?	N/A
	Replace Cross Gutter?	N/A

Possible Solutions:
Remove & Replace Curb Ramp With Two New Directional Ramps or Equivalent.

OC Std/PROW:
 R204.3, R304.5.3, STD 1115
