# Access Compliance Report Public Rights-of-Way (Curb Ramps)

Main Street: MARBLE\_ARCH\_DR Cross Street: APPIAN\_WAY Location: W

ADA ID: RPRK211012181443 Ramp Type: Type 4 - Parallel Initial Pass/Fail: Fail Overall Compliance: No Severity Score: 45

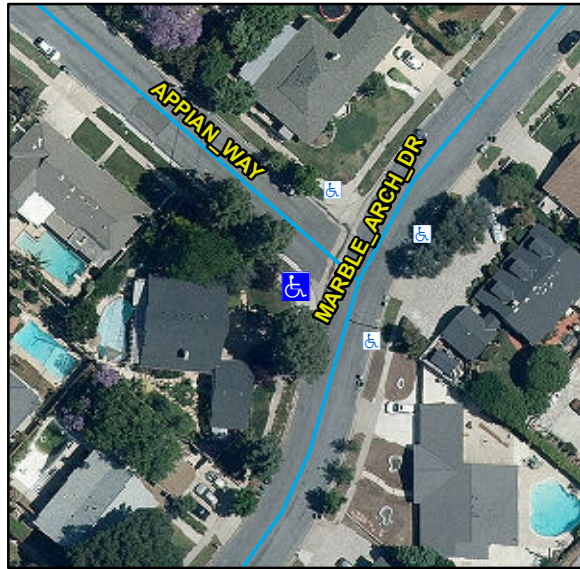
| Compliance | Description | Data | Compliance | Description | Data |
|---|---|---|---|---|---|
| Yes | Ramp Run Slope LT (%) | 2.6 | No | Ramp Run Slope RT (%) | 9.7 |
| No | Ramp Cross Slope LT (%) | 6.1 | No | Ramp Cross Slope RT (%) | 7.2 |

Remove & Replace Curb Ramp With Two New Directional Ramps or Equivalent.
