# Access Compliance Report Public Rights-of-Way (Curb Ramps)

Main Street: APPIAN\_WAY Cross Street: MARBLE\_ARCH\_DR Location: N

ADA ID: RPRK211012181757 Ramp Type: Type 4 - Parallel Initial Pass/Fail: Fail Overall Compliance: No Severity Score: 15

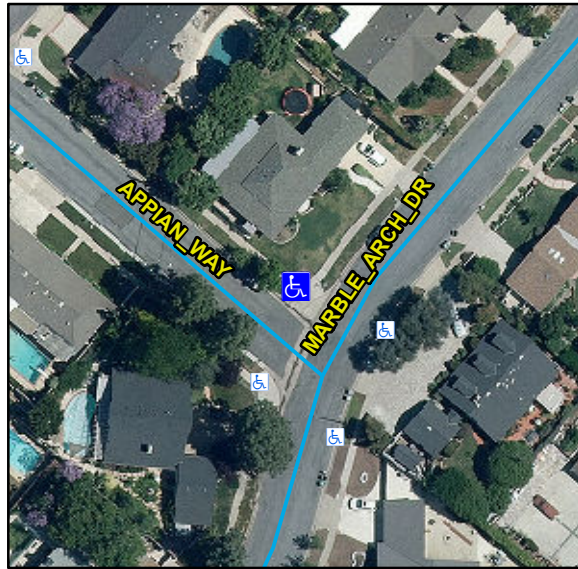
| Compliance | Description | Data | Compliance | Description | Data |
|---|---|---|---|---|---|
| No | Ramp Cross Slope LT (%) | 5.6 | No | Ramp Cross Slope RT (%) | 5.9 |

**Remove & Replace Curb Ramp With Two New Directional Ramps or Equivalent.**

**R304.2.2, R204.3, R304.5.3, STD 1115**
