# Access Compliance Report Public Rights-of-Way (Curb Ramps)

Main Street: HYDE\_PARK\_DR Cross Street: COVENTRY\_PL Location: NE

ADA ID: RPRK211013105011 Ramp Type: Type 4 - Parallel Initial Pass/Fail: Fail Overall Compliance: No Severity Score: 45

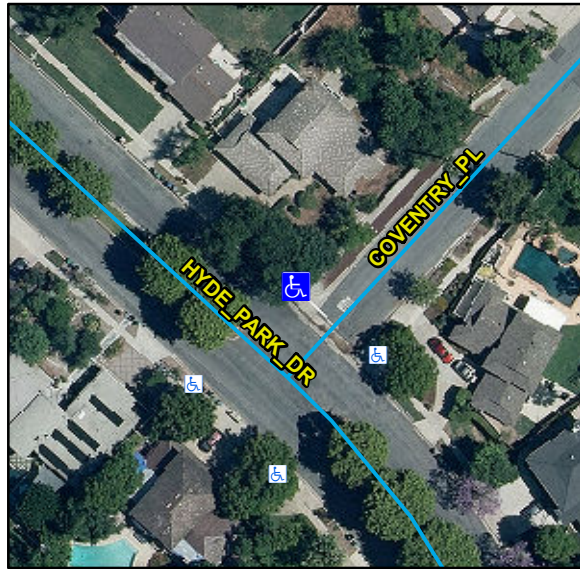
| Compliance | Description | Data | Compliance | Description | Data |
|---|---|---|---|---|---|
| Yes | Ramp Run Slope LT (%) | 2.5 | No | Ramp Run Slope RT (%) | 12.9 |
| No | Ramp Cross Slope LT (%) | 6.1 | No | Ramp Cross Slope RT (%) | 4 |
| No | Gutter Lip Height (in) | 0.25 | | Road Run Slope (%) | 5.7 |

**Remove & Replace Curb Ramp With Two New Directional Ramps or Equivalent. Grind Gutter Lip.**

**R304.5.3, R304.3.2, R302.7.2, STD 1115**
