# Access Compliance Report Public Rights-of-Way (Curb Ramps)

Main Street: COVENTRY\_PL Cross Street: HYDE\_PARK\_DR Location: SE

ADA ID: RPRK211013105322 Ramp Type: Type 4 - Parallel Initial Pass/Fail: Fail Overall Compliance: No Severity Score: 16

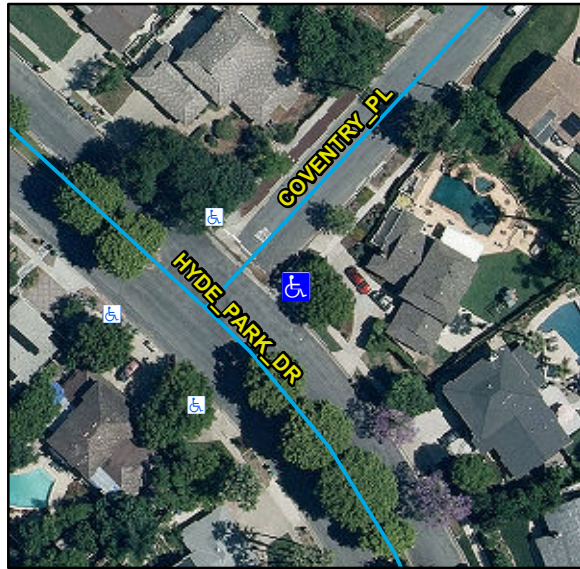
| Compliance | Description | Data | Compliance | Description | Data |
|---|---|---|---|---|---|
| No | Ramp Run Slope LT (%) | 9.3 | Yes | Ramp Run Slope RT (%) | 4.9 |
| No | Ramp Cross Slope LT (%) | 4.9 | No | Ramp Cross Slope RT (%) | 4.8 |

**Remove & Replace Curb Ramp With Two New Directional Ramps or Equivalent.**

**R304.3.2, R304.5.3, STD 1115**
