# Access Compliance Report Public Rights-of-Way (Curb Ramps)

Main Street: BRADCLIFF\_DR Cross Street: COVENTRY\_PL Location: SW

ADA ID: RPRK211013110027 Ramp Type: Type 4 - Parallel Initial Pass/Fail: Fail Overall Compliance: No Severity Score: 32

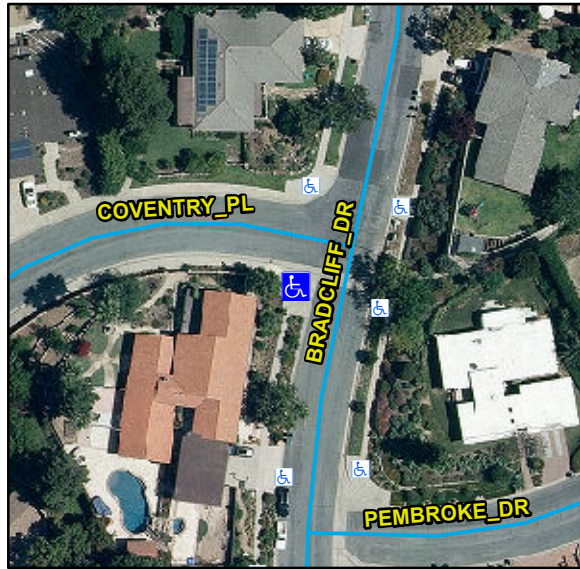
| Compliance | Description | Data | Compliance | Description | Data |
|---|---|---|---|---|---|
| No | Ramp Run Slope LT (%) | 13 | Yes | Ramp Run Slope RT (%) | 0.5 |
| No | Ramp Cross Slope LT (%) | 4.6 | No | Ramp Cross Slope RT (%) | 4.8 |

Remove & Replace Curb Ramp With Two New Directional Ramps or Equivalent.
