# Access Compliance Report Public Rights-of-Way (Curb Ramps)

Main Street: COVENTRY\_PL Cross Street: BRADCLIFF\_DR Location: N

ADA ID: RPRK211013110252 Ramp Type: Type 4 - Parallel Initial Pass/Fail: Fail Overall Compliance: No Severity Score: 30

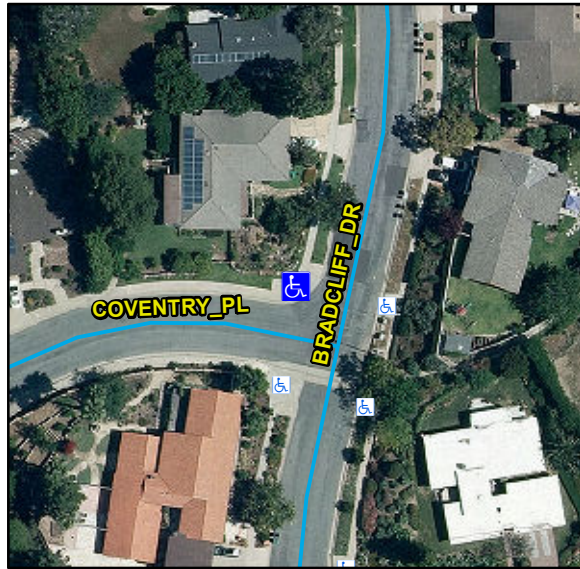
| Compliance | Description | Data | Compliance | Description | Data |
|---|---|---|---|---|---|
| Yes | Ramp Run Slope LT (%) | 5.2 | No | Ramp Run Slope RT (%) | 11 |
| No | Ramp Cross Slope LT (%) | 5.2 | No | Ramp Cross Slope RT (%) | 3.4 |

Remove & Replace Curb Ramp With Two New Directional Ramps or Equivalent.
