# Access Compliance Report Public Rights-of-Way (Curb Ramps)

Main Street: BRADCLIFF\_DR Cross Street: COVENTRY\_PL Location: E

ADA ID: RPRK211013110521 Ramp Type: Type 1 - Perpendicular Initial Pass/Fail: Fail Overall Compliance: No Severity Score: 16

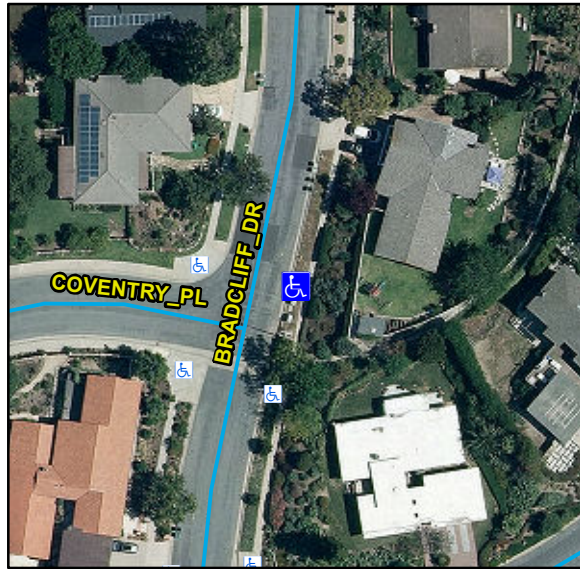
| Compliance | Description | Data | Compliance | Description | Data |
|---|---|---|---|---|---|
| No | Ramp Run Slope (%) | 11.2 | N/A | Flare Slope LT (%) | N/A |
| No | Ramp Cross Slope (%) | 3.3 | N/A | Flare Traversable LT | N/A |

Remove & Replace Entire Ramp.

R204.3, R304.2.2, R304.5.3, STD 1115
