# Access Compliance Report Public Rights-of-Way (Curb Ramps)

Main Street: BRADCLIFF\_DR Cross Street: PEMBROKE\_DR Location: NE

ADA ID: RPRK211013110931 Ramp Type: Type 1 - Perpendicular Diagonal Initial Pass/Fail: Fail Overall Compliance: No Severity Score: 15

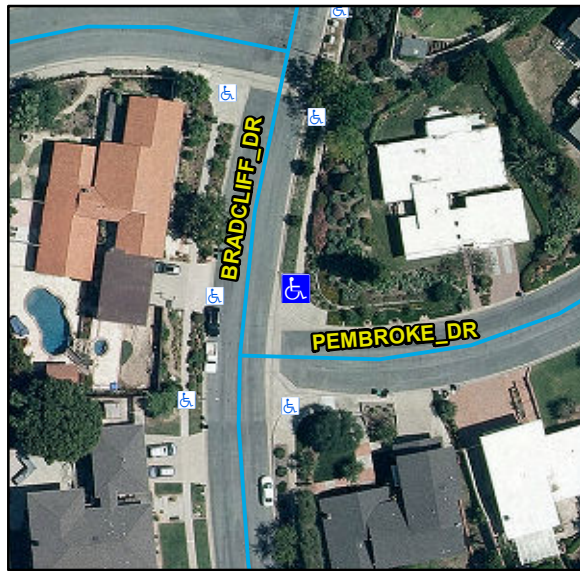
| Compliance | Description | Data | Compliance | Description | Data |
|---|---|---|---|---|---|
| No | Ramp Run Slope (%) | 8.5 | N/A | Flare Slope LT (%) | N/A |

Remove & Replace Curb Ramp With Two New Directional Ramps or Equivalent.

R304.2.2, STD 1115
