# Access Compliance Report Public Rights-of-Way (Curb Ramps)

Main Street: PEMBROKE\_DR Cross Street: BRADCLIFF\_DR Location: SE

ADA ID: RPRK211013111052 Ramp Type: Type 4 - Parallel Initial Pass/Fail: Fail Overall Compliance: No Severity Score: 15

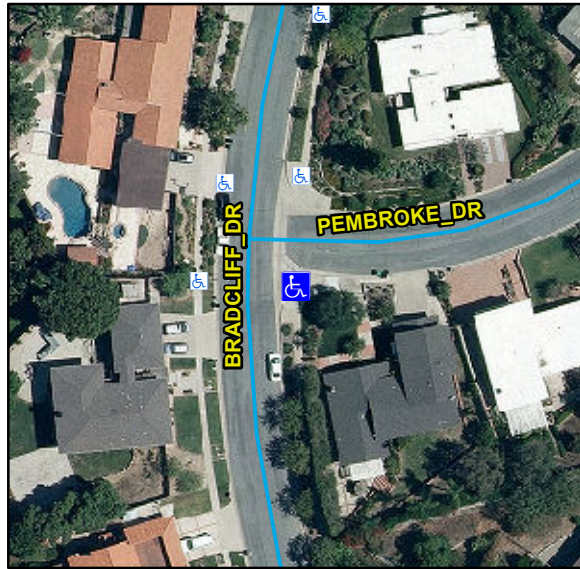
| Compliance | Description | Data | Compliance | Description | Data |
|---|---|---|---|---|---|
| No | Ramp Cross Slope LT (%) | 6 | No | Ramp Cross Slope RT (%) | 3.3 |
| No | Gutter Lip Height (in) | 0.25 | | Road Run Slope (%) | 0.4 |

**Remove & Replace Curb Ramp With Two New Directional Ramps or Equivalent. Grind Gutter Lip.**

**R304.5.3, R302.7.2, STD 1115**
