Access Compliance Report Public Rights-of-Way (Curb Ramps)

Main Street: HYDE_PARK_DR **Cross Street:** WICKFORD_DR **Location:** NE

ADA ID: RPRK211013111954 **Ramp Type:** Type 4 - Parallel **Initial Pass/Fail:** Fail **Overall Compliance:** No **Severity Score:** 30

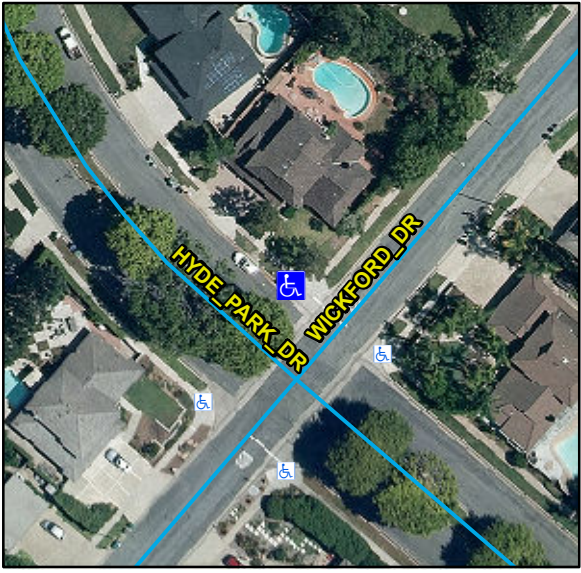
Compliance	Description	Data	Compliance	Description	Data
N/A	Ramp Length LT (in)	126	N/A	Ramp Length RT (in)	122
Yes	Ramp Width LT (in)	118	Yes	Ramp Width RT (in)	121
Yes	Ramp Run Slope LT (%)	5.7	No	Ramp Run Slope RT (%)	8.6
No	Ramp Cross Slope LT (%)	6.8	No	Ramp Cross Slope RT (%)	5.6
N/A	Landing Present	N/A	N/A	DWS Provided	N/A
N/A	Landing Length (in)	N/A	N/A	DWS Contrast	N/A
N/A	Landing Width (in)	N/A	N/A	DWS Length (in)	N/A
N/A	Landing Run Slope (%)	N/A	N/A	DWS Full Width	N/A
N/A	Landing Cross Slope (%)	N/A		DWS Offset Type	N/A
N/A	Landing Movement Obstructed?	N/A	N/A	DWS Offset Left (in)	N/A
	Landing Movement Type	N/A	N/A	DWS Offset Right (in)	N/A
N/A	Landing Shared	N/A			
N/A	Clear Space	Yes			
N/A	Clear Space To Crosswalk (in)	N/A			
N/A	Marked Crosswalk 1	No	N/A	Marked Crosswalk 2	No
	Crossing 1 Direction	SW		Crossing 2 Direction	SE
	Marked Crosswalk 1 Width (in)	N/A		Marked Crosswalk 2 Width (in)	N/A

N/A	Ramp Inside Crosswalk 1	N/A	N/A	Ramp Inside Crosswalk 2	N/A
	Crossing 1 Slope (%)	4.3		Crossing 2 Slope (%)	4
	Crossing 1 Cross Slope (%)	4.6		Crossing 2 Cross Slope (%)	3.3
N/A	Gutter Ponding	N/A	N/A	Curb Slope	1.9
Yes	Gutter Lip Height (in)	0		Road Run Slope (%)	2.2
N/A	Gutter Run Slope (%)	N/A		Road Cross Slope (%)	8.9
N/A	Gutter Cross Slope (%)	N/A	Yes	Perpendicular Joint Present	Yes
Yes	Overall Surface Condition	Acceptable			
	Cross Gutter Present?	Yes		Spandrel Present?	Yes
	Replace Cross Gutter?	No		Replace Spandrel?	No

Possible Solutions:
Remove & Replace Curb Ramp With Two New Directional Ramps or Equivalent.

OC Std/PROW:
 R304.5.3, R304.3.2, STD 1115

Total Cost: \$ 4000

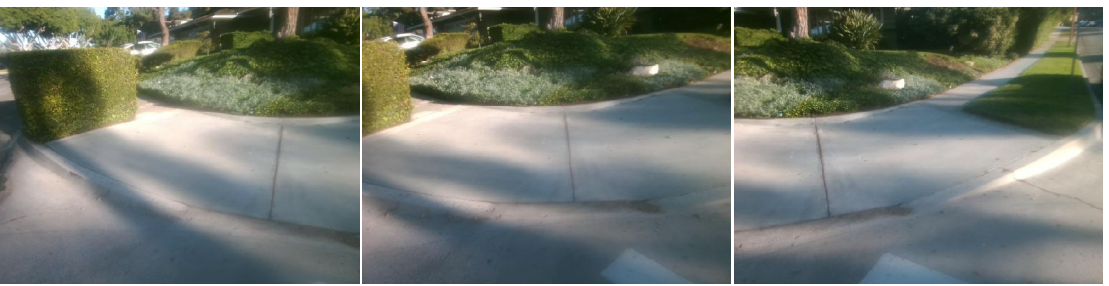
Compliance	Description	Data	Compliance	Description	Data
Yes	Obstructions Present?	No	N/A	Utilities Present?	No
	Obstruction Types	N/A		Utility Types	
	Obstruction Dimensions	N/A			N/A
