# Access Compliance Report Public Rights-of-Way (Curb Ramps)

| Main Street: WICKFORD_DR | | Cross Street: HYDE_PARK_DR | | Location: | SE |
| ADA ID: RPRK211013112226 | Ramp Type: Type 4 - Parallel | Initial Pass/Fail: Fail | Overall Compliance: No | Severity Score: | 30 |

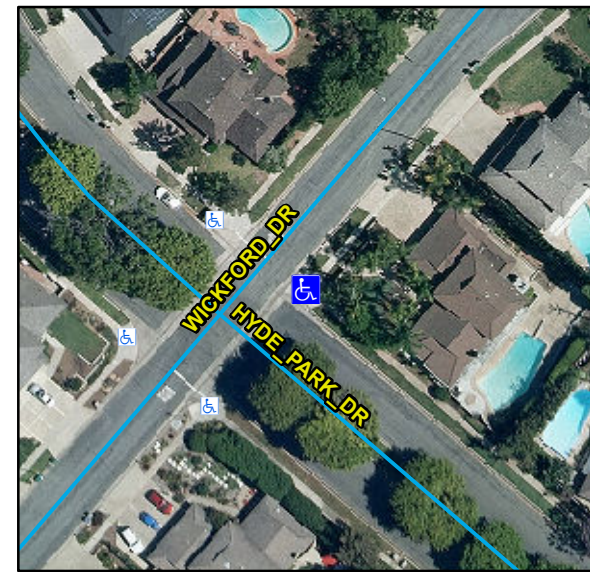
| Compliance | Description | Data | Compliance | Description | Data |
|---|---|---|---|---|---|
| No | Ramp Run Slope LT (%) | 9.3 | Yes | Ramp Run Slope RT (%) | 7.8 |
| No | Ramp Cross Slope LT (%) | 4.8 | No | Ramp Cross Slope RT (%) | 5.6 |

**Remove & Replace Curb Ramp With Two New Directional Ramps or Equivalent.**

**R304.3.2, R304.5.3, STD 1115**

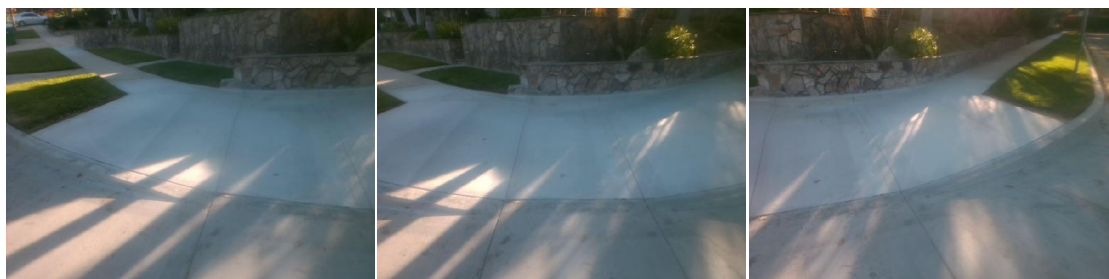
| Compliance | Description | Data | Compliance | Description | Data |
|---|---|---|---|---|---|
| N/A | Ramp Length LT (in) | 93 | N/A | Ramp Length RT (in) | 94 |
| Yes | Ramp Width LT (in) | 120 | Yes | Ramp Width RT (in) | 118 |
