# Access Compliance Report Public Rights-of-Way (Curb Ramps)

**Main Street:** HYDE\_PARK\_DR      **Cross Street:** WICKFORD\_DR      **Location:** SW

**ADA ID:** RPRK211013112626      **Ramp Type:** Type 1 - Perpendicular Diagonal Initial Pass/Fail: Fail      **Overall Compliance:** No      **Severity Score:** 2

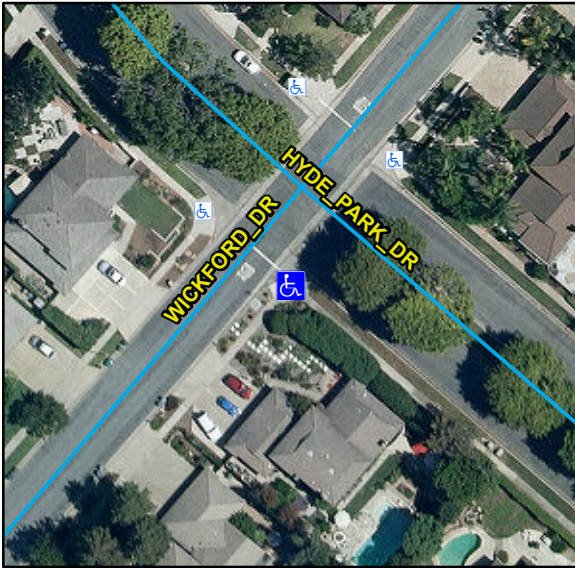
**OC Std/PROW:**  
 R304.2.2, R304.5.3, STD 1115

Compliance	Description	Data	Compliance	Description	Data
N/A	Ramp Length (in)	121	N/A	Flare Type LT	
Yes	Ramp Width (in)	48			N/A
Yes	Ramp Run Slope (%)	7.6	N/A	Flare Slope LT (%)	N/A
No	Ramp Cross Slope (%)	3.7	N/A	Flare Traversable LT	N/A
N/A	Landing Present	N/A	N/A	Flare Type RT	
N/A	Landing Length (in)	N/A			N/A
N/A	Landing Width (in)	N/A	N/A	Flare Slope RT (%)	N/A
N/A	Landing Run Slope (%)	N/A	N/A	Flare Traversable RT	N/A
N/A	Landing Cross Slope (%)	N/A	N/A	DWS Provided	N/A
N/A	Landing Movement Obstructed?	N/A	N/A	DWS Contrast	N/A
	Landing Movement Type	N/A	N/A	DWS Length (in)	N/A
N/A	Landing Shared	N/A	N/A	DWS Full Width	N/A
N/A	Clear Space	Yes	N/A	DWS Offset Left (in)	N/A
N/A	Clear Space To Crosswalk (in)	N/A	N/A	DWS Offset Right (in)	N/A
N/A	Marked Crosswalk 1	No	N/A	Marked Crosswalk 2	No
	Crossing 1 Direction	NE		Crossing 2 Direction	NW
	Marked Crosswalk 1 Width (in)	N/A		Marked Crosswalk 2 Width (in)	N/A

N/A	Ramp Inside Crosswalk 1	N/A	Yes	Ramp Inside Crosswalk 2	N/A
	Crossing 1 Slope (%)	5		Crossing 2 Slope (%)	3.5
	Crossing 1 Cross Slope (%)	6.6		Crossing 2 Cross Slope (%)	4.2
N/A	Gutter Ponding	N/A	No	Curb Slope	7.9
Yes	Gutter Lip Height (in)	0		Road Run Slope (%)	2.3
N/A	Gutter Run Slope (%)	N/A		Road Cross Slope (%)	5.8
N/A	Gutter Cross Slope (%)	N/A			
Yes	Overall Surface Condition: <b>Acceptable</b>		Yes	Perp Joint Present	Yes
	Cross Gutter Present?	Yes		Spandrel Present?	Yes
	Replace Cross Gutter?	No		Replace Spandrel?	No

**Possible Solutions:**  
**Remove & Replace Curb Ramp With Two New Directional Ramps or Equivalent.**

**Total Cost:** \$ 6160
