# Access Compliance Report Public Rights-of-Way (Curb Ramps)

Main Street: WICKFORD\_DR Cross Street: HYDE\_PARK\_DR Location: NW

ADA ID: RPRK211013112839 Ramp Type: Type 1 - Perpendicular Diagonal Initial Pass/Fail: Fail Overall Compliance: No Severity Score: 15

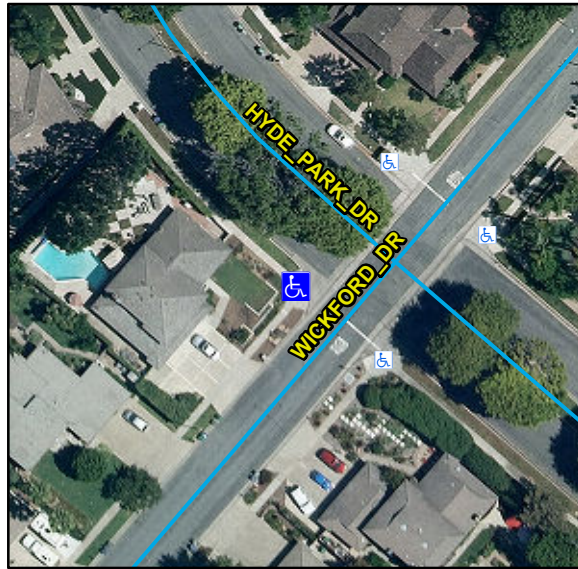
| Compliance | Description | Data | Compliance | Description | Data |
|---|---|---|---|---|---|
| No | Ramp Cross Slope (%) | 6.2 | N/A | Flare Traversable LT | N/A |

**Remove & Replace Curb Ramp With Two New Directional Ramps or Equivalent.**

**R304.5.3, STD 1115**
