# Access Compliance Report Public Rights-of-Way (Curb Ramps)

Main Street: ARROYO\_AVE Cross Street: EDGEVIEW\_DR Location: NW

ADA ID: RPRK211013114140 Ramp Type: Type 4 - Parallel Initial Pass/Fail: Fail Overall Compliance: No Severity Score: 30

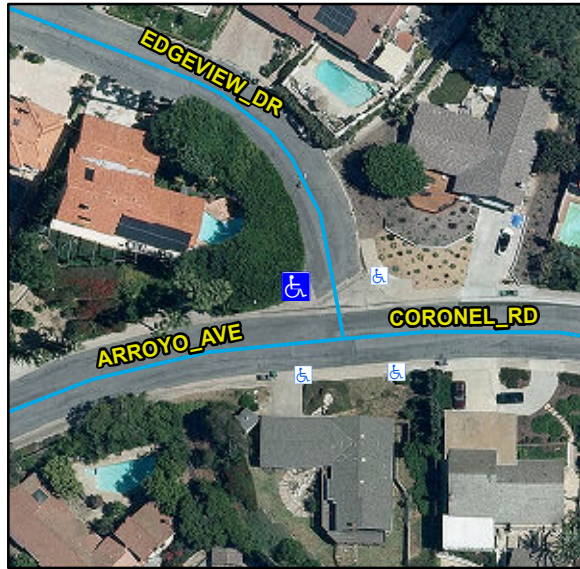
| Compliance | Description | Data | Compliance | Description | Data |
|---|---|---|---|---|---|
| Yes | Ramp Run Slope LT (%) | 4.6 | No | Ramp Run Slope RT (%) | 11.8 |
| No | Ramp Cross Slope LT (%) | 5.1 | No | Ramp Cross Slope RT (%) | 5.4 |

Remove & Replace Curb Ramp With Two New Directional Ramps or Equivalent.
