# Access Compliance Report Public Rights-of-Way (Curb Ramps)

| Main Street: EDGEVIEW_DR | | Cross Street: CORONEL_RD | | Location: | NE |
| ADA ID: RPRK211013114408 | Ramp Type: Type 4 - Parallel | Initial Pass/Fail: Fail | Overall Compliance: No | Severity Score: | 30 |

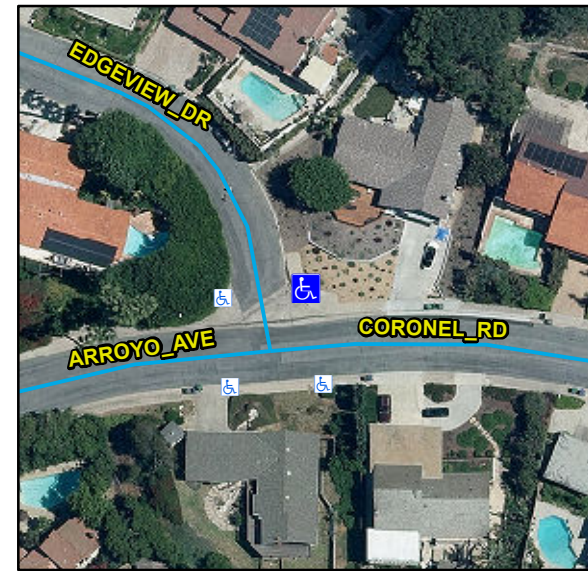
| Compliance | Description | Data | Compliance | Description | Data |
|---|---|---|---|---|---|
| Yes | Ramp Run Slope LT (%) | 1.5 | No | Ramp Run Slope RT (%) | 10 |
| No | Ramp Cross Slope LT (%) | 5.4 | No | Ramp Cross Slope RT (%) | 4.8 |

**Remove & Replace Curb Ramp With Two New Directional Ramps or Equivalent.**

**R204.3, R304.5.3, R304.3.2, STD 1115**

Total Cost: \$ 4000
