# Access Compliance Report Public Rights-of-Way (Curb Ramps)

Main Street: ARROYO\_AVE Cross Street: MUMFORD\_RD Location: SE

ADA ID: RPRK211013114805 Ramp Type: Type 1 - Perpendicular Diagonal Initial Pass/Fail: Pass Overall Compliance: No Severity Score: 45

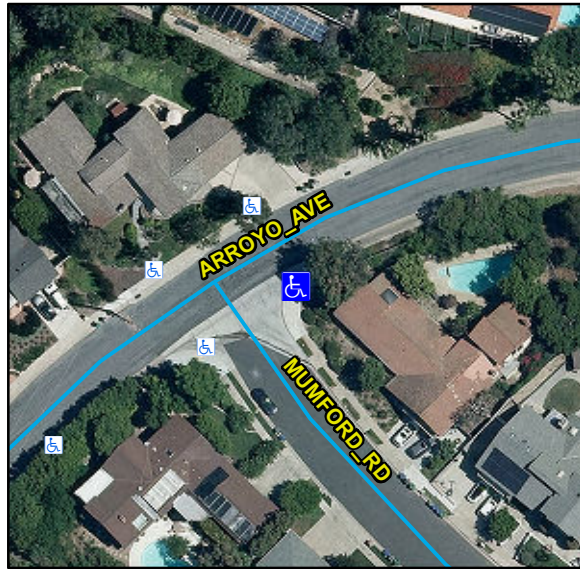
| Compliance | Description | Data | Compliance | Description | Data |
|---|---|---|---|---|---|
| Yes | Ramp Run Slope (%) | 7.7 | No | Flare Slope LT (%) | 15.8 |
| No | Ramp Cross Slope (%) | 10.3 | N/A | Flare Traversable LT | Yes |
| No | Landing Cross Slope (%) | 12.6 | Yes | DWS Provided | Yes |
| No | Gutter Run Slope (%) | 11.6 | | Road Cross Slope (%) | 7.4 |
| No | Gutter Cross Slope (%) | 5.7 | | | |

Remove & Replace Curb Ramp With Two New Directional Ramps or Equivalent. Remove & Replace Gutter.
