# Access Compliance Report Public Rights-of-Way (Curb Ramps)

| Main Street: GLENAIRE_DR | | Cross Street: ARROYO_AVE | | Location: | N |
| ADA ID: RPRK211013115457 | Ramp Type: Type 4 - Parallel | Initial Pass/Fail: Fail | Overall Compliance: No | Severity Score: | 45 |

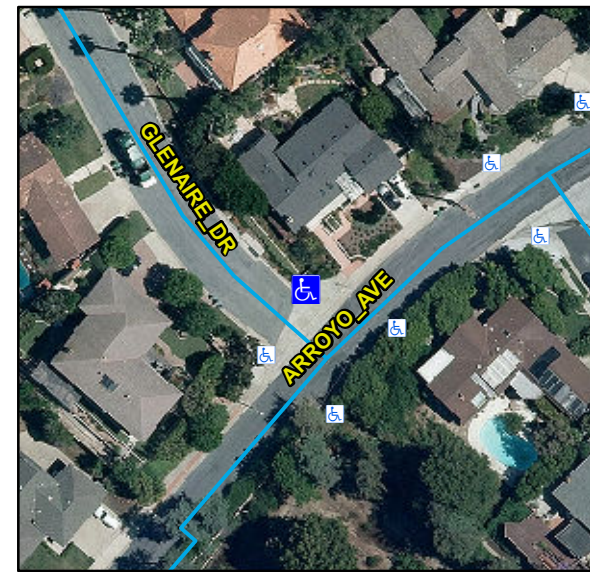
| Compliance | Description | Data | Compliance | Description | Data |
|---|---|---|---|---|---|
| Yes | Ramp Run Slope LT (%) | 4.8 | No | Ramp Run Slope RT (%) | 19 |
| No | Ramp Cross Slope LT (%) | 6.2 | No | Ramp Cross Slope RT (%) | 4.3 |
| No | Gutter Lip Height (in) | 0.25 | | Road Run Slope (%) | 10.8 |

**Remove & Replace Curb Ramp With Two New Directional Ramps or Equivalent. Grind Gutter Lip.**

**R204.3, R304.5.3, R304.3.2, R302.7.2, STD 1115**

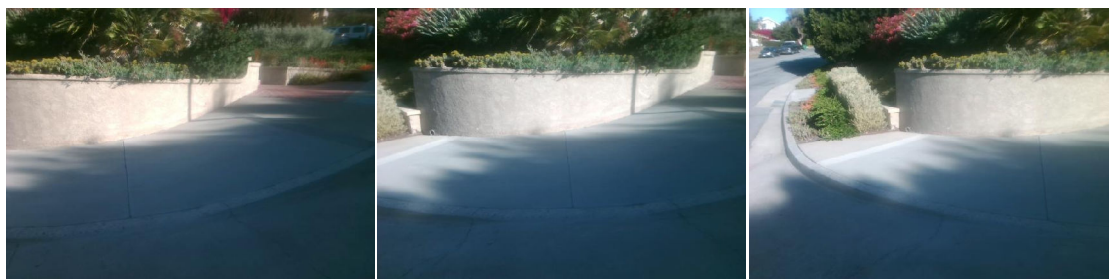
| Compliance | Description | Data | Compliance | Description | Data |
|---|---|---|---|---|---|
| N/A | Ramp Length LT (in) | 128 | N/A | Ramp Length RT (in) | 122 |
| Yes | Ramp Width LT (in) | 103 | Yes | Ramp Width RT (in) | 116 |
