# Access Compliance Report Public Rights-of-Way (Curb Ramps)

| Main Street: ARROYO_AVE | | Cross Street: GLENAIRE_DR | | Location: | W |
| ADA ID: RPRK211013115722 | Ramp Type: Type 4 - Parallel | Initial Pass/Fail: Fail | Overall Compliance: No | Severity Score: | 45 |

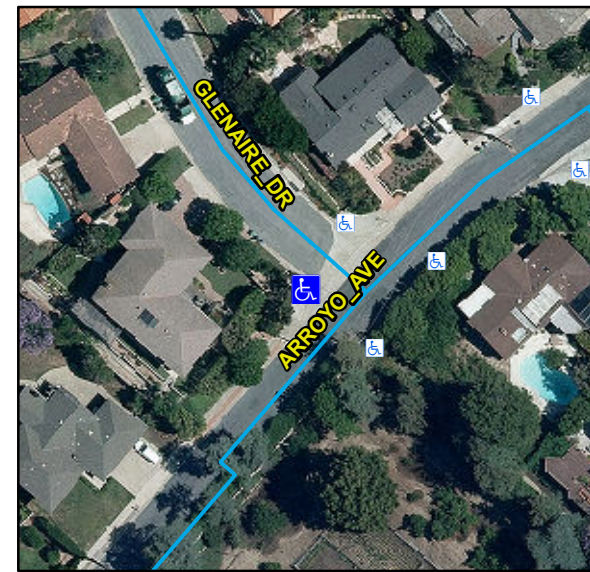
| Compliance | Description | Data | Compliance | Description | Data |
|---|---|---|---|---|---|
| No | Ramp Run Slope LT (%) | 9.3 | No | Ramp Run Slope RT (%) | 19.5 |
| No | Ramp Cross Slope LT (%) | 6.8 | No | Ramp Cross Slope RT (%) | 4.5 |

**Remove & Replace Curb Ramp With Two New Directional Ramps or Equivalent.**

**R204.3, R304.3.2, R304.5.3, STD 1115**
