# Access Compliance Report Public Rights-of-Way (Curb Ramps)

| Main Street: CORONEL_RD | | Cross Street: THORLEY_RD | | Location: | NW |
| ADA ID: RPRK211013120356 | Ramp Type:Type 1 - Perpendicular | Initial Pass/Fail: Fail | Overall Compliance: No | Severity Score: | 15 |

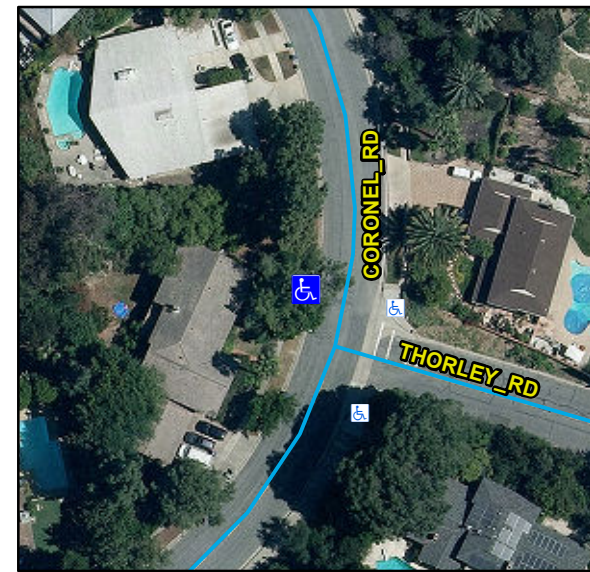
| Compliance | Description | Data | Compliance | Description | Data |
|---|---|---|---|---|---|
| No | Ramp Run Slope (%) | 11.1 | N/A | Flare Slope LT (%) | N/A |

**Remove & Replace Entire Ramp.**

**R204.3, R304.2.2, STD 1115**

Total Cost: \$ 3080
