# Access Compliance Report Public Rights-of-Way (Curb Ramps)

| Main Street: CORONEL_RD | | Cross Street: THORLEY_RD | | Location: | NE |
| ADA ID: RPRK211013120656 | Ramp Type: Type 4 - Parallel | Initial Pass/Fail: Fail | Overall Compliance: No | Severity Score: | 15 |

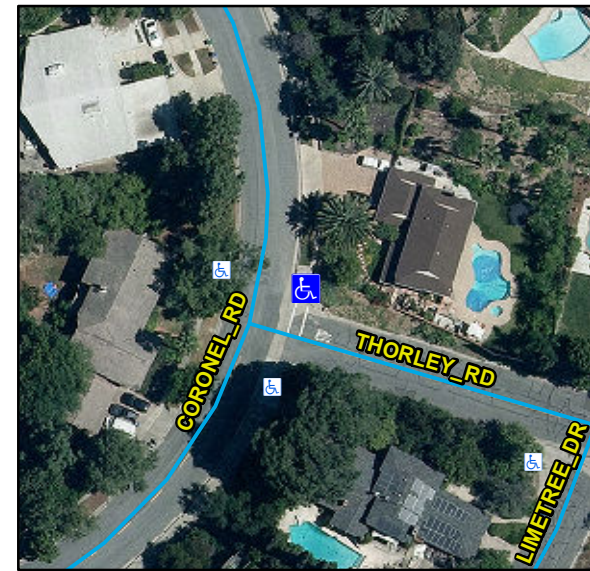
| Compliance | Description | Data | Compliance | Description | Data |
|---|---|---|---|---|---|
| No | Ramp Run Slope LT (%) | 11.3 | Yes | Ramp Run Slope RT (%) | 8 |

**Remove & Replace Curb Ramp With Two New Directional Ramps or Equivalent.**

**R204.3, R304.3.2, STD 1115**

Total Cost: \$ 4000

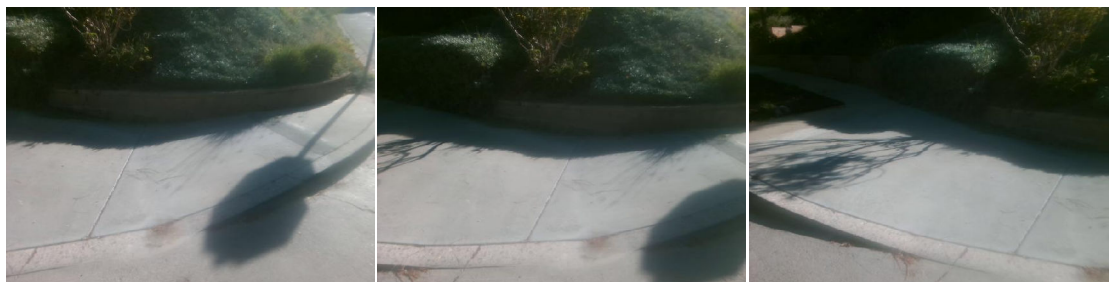
| Compliance | Description | Data | Compliance | Description | Data |
|---|---|---|---|---|---|
| N/A | Ramp Length LT (in) | 130 | N/A | Ramp Length RT (in) | 100 |
| Yes | Ramp Width LT (in) | 114 | Yes | Ramp Width RT (in) | 76 |
| Yes | Ramp Cross Slope LT (%) | 1 | Yes | Ramp Cross Slope RT (%) | 0.9 |
