# Access Compliance Report Public Rights-of-Way (Curb Ramps)

**Main Street:** THORLEY\_RD      **Cross Street:** CORONEL\_RD      **Location:** SE

**ADA ID:** RPRK211013120924      **Ramp Type:** Type 4 - Parallel      **Initial Pass/Fail:** Fail      **Overall Compliance:** No      **Severity Score:** 2

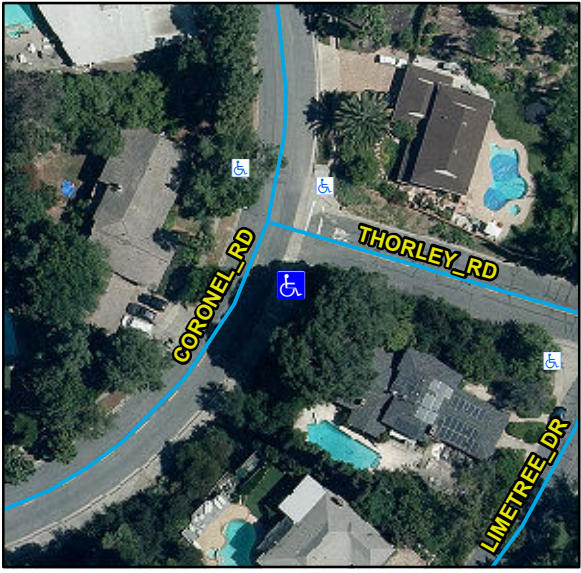
Compliance	Description	Data	Compliance	Description	Data
N/A	Ramp Length LT (in)	120	N/A	Ramp Length RT (in)	129
Yes	Ramp Width LT (in)	83	Yes	Ramp Width RT (in)	100
Yes	Ramp Run Slope LT (%)	6.8	Yes	Ramp Run Slope RT (%)	1.9
No	Ramp Cross Slope LT (%)	5	No	Ramp Cross Slope RT (%)	3.1
N/A	Landing Present	N/A	N/A	DWS Provided	N/A
N/A	Landing Length (in)	N/A	N/A	DWS Contrast	N/A
N/A	Landing Width (in)	N/A	N/A	DWS Length (in)	N/A
N/A	Landing Run Slope (%)	N/A	N/A	DWS Full Width	N/A
N/A	Landing Cross Slope (%)	N/A		DWS Offset Type	N/A
N/A	Landing Movement Obstructed?	N/A	N/A	DWS Offset Left (in)	N/A
	Landing Movement Type	N/A	N/A	DWS Offset Right (in)	N/A
N/A	Landing Shared	N/A			
N/A	Clear Space	Yes			
N/A	Clear Space To Crosswalk (in)	N/A			
N/A	Marked Crosswalk 1	No	N/A	Marked Crosswalk 2	No
	Crossing 1 Direction	N		Crossing 2 Direction	W
N/A	Marked Crosswalk 1 Width (in)	N/A		Marked Crosswalk 2 Width (in)	N/A

N/A	Ramp Inside Crosswalk 1	N/A	N/A	Ramp Inside Crosswalk 2	N/A
	Crossing 1 Slope (%)	9.4		Crossing 2 Slope (%)	0.4
	Crossing 1 Cross Slope (%)	2		Crossing 2 Cross Slope (%)	2.5
N/A	Gutter Ponding	N/A	N/A	Curb Slope	0.4
Yes	Gutter Lip Height (in)	0		Road Run Slope (%)	4.3
N/A	Gutter Run Slope (%)	N/A		Road Cross Slope (%)	0.8
N/A	Gutter Cross Slope (%)	N/A	No	Perpendicular Joint Present	No
Yes	Overall Surface Condition	Acceptable			
	Cross Gutter Present?	Yes		Spandrel Present?	Yes
	Replace Cross Gutter?	No		Replace Spandrel?	No

**Possible Solutions:**  
**Remove & Replace Curb Ramp With Two New Directional Ramps or Equivalent.**

**OC Std/PROW:**  
 R204.3, R304.5.3, STD 1115

**Total Cost:** \$ 4000
