# Access Compliance Report Public Rights-of-Way (Curb Ramps)

| Main Street: CHERRY_HILL_DR | | Cross Street: CORONEL_RD | | Location: | NE |
| ADA ID: RPRK211013121423 | Ramp Type: Type 4 - Parallel | Initial Pass/Fail: Fail | Overall Compliance: No | Severity Score: | 45 |

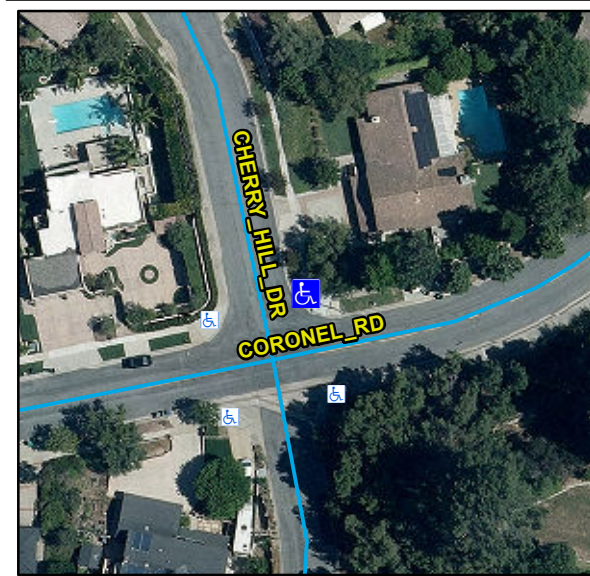
| Compliance | Description | Data | Compliance | Description | Data |
|---|---|---|---|---|---|
| Yes | Ramp Run Slope LT (%) | 6.8 | No | Ramp Run Slope RT (%) | 11.7 |
| No | Ramp Cross Slope LT (%) | 6.1 | No | Ramp Cross Slope RT (%) | 7.7 |

**Remove & Replace Curb Ramp With Two New Directional Ramps or Equivalent.**

**R204.3, R304.5.3, R304.3.2, STD 1115**
