# Access Compliance Report Public Rights-of-Way (Curb Ramps)

| Main Street: CORONEL_RD | | Cross Street: CHERRY_HILL_DR | | Location: | NW |
| ADA ID: RPRK211013121711 | Ramp Type: Type 4 - Parallel | Initial Pass/Fail: Pass | Overall Compliance: No | Severity Score: | 35 |

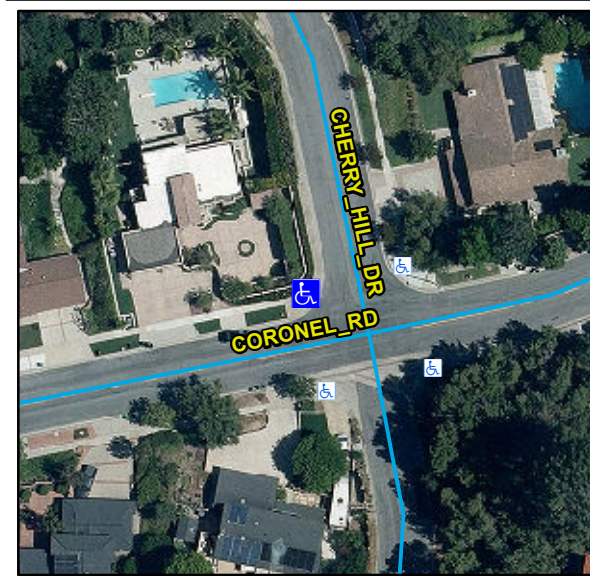
| Compliance | Description | Data | Compliance | Description | Data |
|---|---|---|---|---|---|
| No | Ramp Cross Slope LT (%) | 5.2 | No | Ramp Cross Slope RT (%) | 2.9 |
| N/A | Landing Present | No | No | DWS Provided | No |
| No | Landing Width (in) | N/A | N/A | DWS Length (in) | N/A |
| No | Landing Run Slope (%) | N/A | N/A | DWS Full Width | N/A |
| No | Landing Cross Slope (%) | N/A | | DWS Offset Type | N/A |
| No | Gutter Cross Slope (%) | 6.7 | No | Perpendicular Joint Present | No |

**Remove & Replace Curb Ramp With Two New Directional Ramps or Equivalent. Remove & Replace Gutter.**

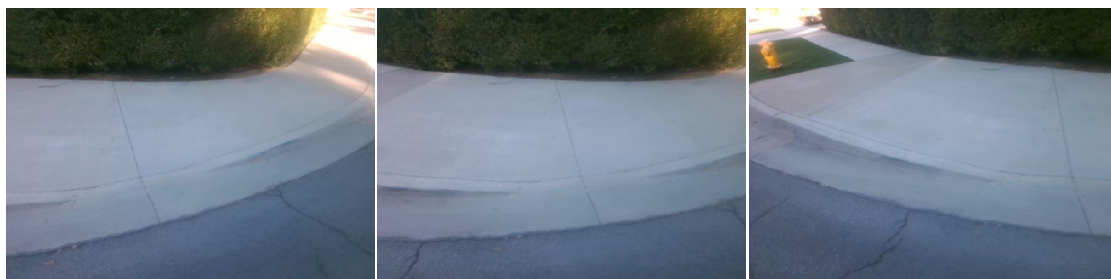
| Compliance | Description | Data | Compliance | Description | Data |
|---|---|---|---|---|---|
| N/A | Ramp Length LT (in) | 121 | N/A | Ramp Length RT (in) | 132 |
| Yes | Ramp Width LT (in) | 115 | Yes | Ramp Width RT (in) | 90 |
| Yes | Ramp Run Slope LT (%) | 1.5 | Yes | Ramp Run Slope RT (%) | 4.4 |
