# Access Compliance Report Public Rights-of-Way (Curb Ramps)

Main Street: CORONEL\_RD Cross Street: CHERRY\_HILL\_DR Location: SE

ADA ID: RPRK211013122017 Ramp Type: Type 4 - Parallel Initial Pass/Fail: Fail Overall Compliance: No Severity Score: 30

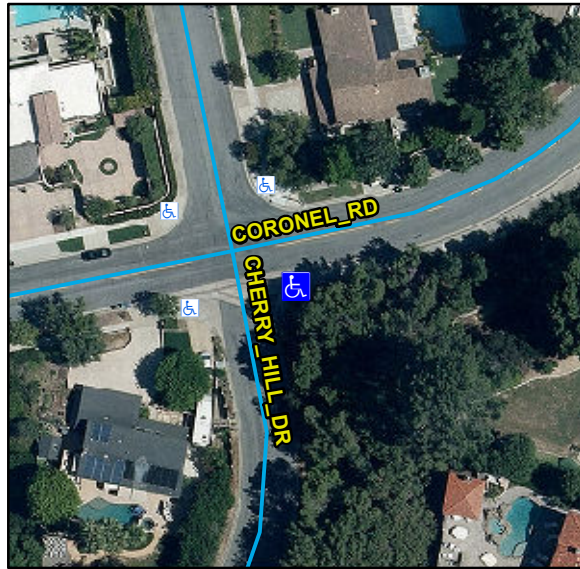
| Compliance | Description | Data | Compliance | Description | Data |
|---|---|---|---|---|---|
| No | Ramp Run Slope LT (%) | 10.6 | Yes | Ramp Run Slope RT (%) | 1 |
| Yes | Ramp Cross Slope LT (%) | 0.9 | No | Ramp Cross Slope RT (%) | 6.7 |
| No | Gutter Lip Height (in) | 0.25 | | Road Run Slope (%) | 7.4 |

Remove & Replace Curb Ramp With Two New Directional Ramps or Equivalent. Grind Gutter Lip.
