Access Compliance Report Public Rights-of-Way (Curb Ramps)

Main Street: CHERRY_HILL_DR **Cross Street:** CORONEL_RD **Location:** SW

ADA ID: RPRK211013122220 **Ramp Type:** Type 4 - Parallel **Initial Pass/Fail:** Fail **Overall Compliance:** No **Severity Score:** 16

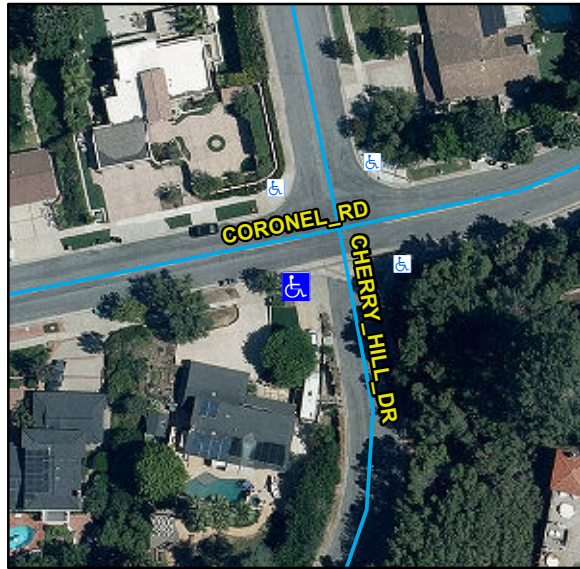
Compliance	Description	Data	Compliance	Description	Data
N/A	Ramp Length LT (in)	121	N/A	Ramp Length RT (in)	122
Yes	Ramp Width LT (in)	92	Yes	Ramp Width RT (in)	144
No	Ramp Run Slope LT (%)	9.6	Yes	Ramp Run Slope RT (%)	4.6
No	Ramp Cross Slope LT (%)	3.8	No	Ramp Cross Slope RT (%)	3
N/A	Landing Present	N/A	N/A	DWS Provided	N/A
N/A	Landing Length (in)	N/A	N/A	DWS Contrast	N/A
N/A	Landing Width (in)	N/A	N/A	DWS Length (in)	N/A
N/A	Landing Run Slope (%)	N/A	N/A	DWS Full Width	N/A
N/A	Landing Cross Slope (%)	N/A		DWS Offset Type	N/A
N/A	Landing Movement Obstructed?	N/A	N/A	DWS Offset Left (in)	N/A
	Landing Movement Type	N/A	N/A	DWS Offset Right (in)	N/A
N/A	Landing Shared	N/A			
N/A	Clear Space	Yes			
N/A	Clear Space To Crosswalk (in)	N/A			
N/A	Marked Crosswalk 1	No	N/A	Marked Crosswalk 2	No
	Crossing 1 Direction	E		Crossing 2 Direction	N
N/A	Marked Crosswalk 1 Width (in)	N/A	N/A	Marked Crosswalk 2 Width (in)	N/A

N/A	Ramp Inside Crosswalk 1	N/A	N/A	Ramp Inside Crosswalk 2	N/A
	Crossing 1 Slope (%)	4.7		Crossing 2 Slope (%)	0.5
	Crossing 1 Cross Slope (%)	7.1		Crossing 2 Cross Slope (%)	11.1
N/A	Gutter Ponding	N/A	N/A	Curb Slope	2.8
Yes	Gutter Lip Height (in)	0		Road Run Slope (%)	13.9
N/A	Gutter Run Slope (%)	N/A		Road Cross Slope (%)	2.6
N/A	Gutter Cross Slope (%)	N/A	No	Perpendicular Joint Present	No
Yes	Overall Surface Condition	Acceptable		Spandrel Present?	Yes
	Cross Gutter Present?	Yes		Replace Spandrel?	No
	Replace Cross Gutter?	No

Possible Solutions:
Remove & Replace Curb Ramp With Two New Directional Ramps or Equivalent.

OC Std/PROW:
 R204.3, R304.3.2, R304.5.3, STD 1115

Total Cost: \$ 4000

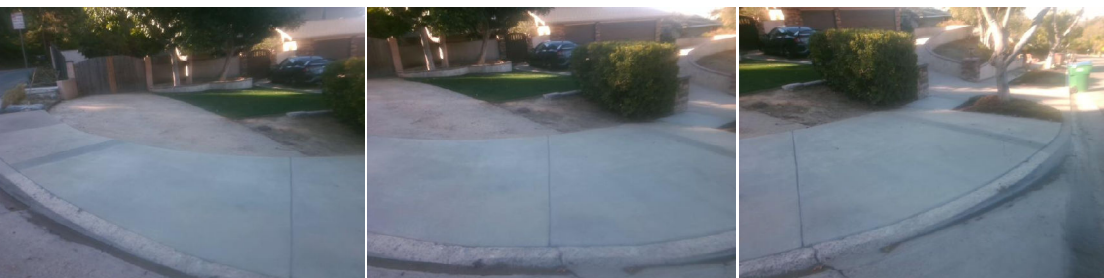
Compliance	Description	Data	Compliance	Description	Data
Yes	Obstructions Present?	No	N/A	Utilities Present?	No
	Obstruction Types	N/A		Utility Types	
	Obstruction Dimensions	N/A			N/A
