# Access Compliance Report Public Rights-of-Way (Curb Ramps)

| Main Street: CORONEL_RD | | Cross Street: YARMOUTH_RD | | Location: | SE |
| ADA ID: RPRK211013122610 | Ramp Type: Type 4 - Parallel | Initial Pass/Fail: Fail | Overall Compliance: No | Severity Score: | 45 |

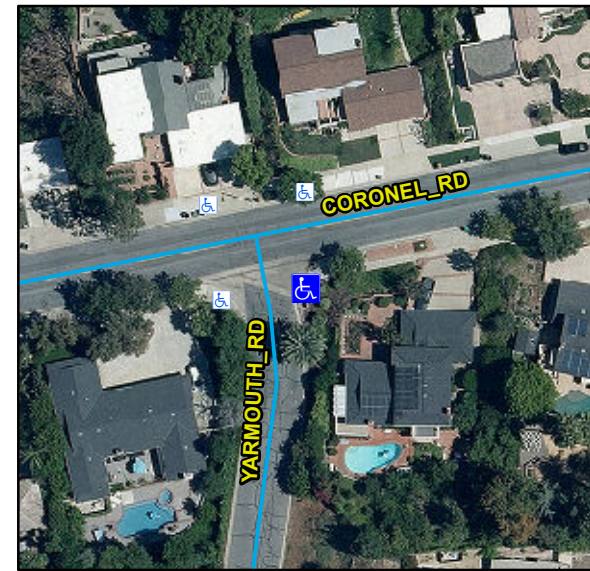
| Compliance | Description | Data | Compliance | Description | Data |
|---|---|---|---|---|---|
| No | Ramp Run Slope LT (%) | 10.6 | Yes | Ramp Run Slope RT (%) | 0.3 |
| No | Ramp Cross Slope LT (%) | 4.4 | No | Ramp Cross Slope RT (%) | 8.6 |
| No | Gutter Lip Height (in) | 0.27 | | Road Run Slope (%) | 1.5 |

**Remove & Replace Curb Ramp With Two New Directional Ramps or Equivalent. Grind Gutter Lip.**
