# Access Compliance Report Public Rights-of-Way (Curb Ramps)

Main Street: YARMOUTH\_RD Cross Street: CORONEL\_RD Location: SW

ADA ID: RPRK211013122826 Ramp Type: Type 4 - Parallel Initial Pass/Fail: Fail Overall Compliance: No Severity Score: 45

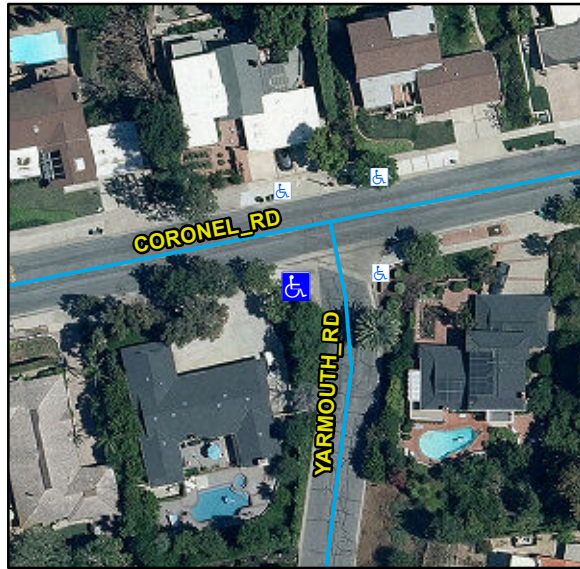
| Compliance | Description | Data | Compliance | Description | Data |
|---|---|---|---|---|---|
| No | Ramp Run Slope LT (%) | 11.7 | Yes | Ramp Run Slope RT (%) | 4.7 |
| No | Ramp Cross Slope LT (%) | 5.3 | No | Ramp Cross Slope RT (%) | 7.3 |

Remove & Replace Curb Ramp With Two New Directional Ramps or Equivalent.
