# Access Compliance Report Public Rights-of-Way (Curb Ramps)

Main Street: ADDISON\_RD Cross Street: CORONEL\_RD Location: S

ADA ID: RPRK211013123356 Ramp Type: Type 6 - Directional 1 Initial Pass/Fail: Fail Overall Compliance: No Severity Score: 16

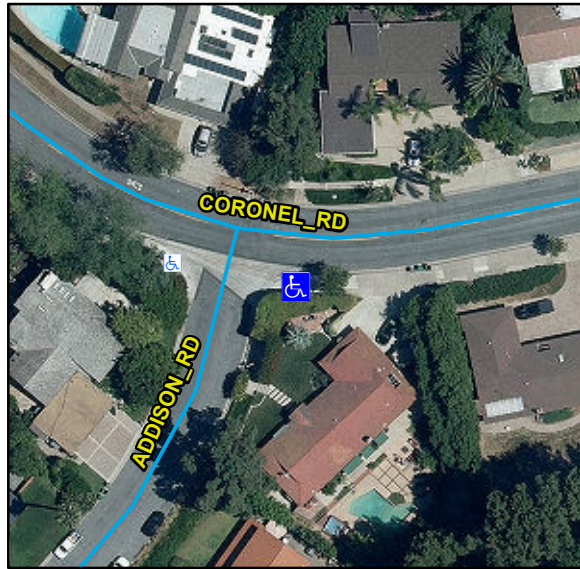
| Compliance | Description | Data | Compliance | Description | Data |
|---|---|---|---|---|---|
| No | Ramp Cross Slope (%) | 2.1 | N/A | Flare Traversable LT | N/A |

Remove & Replace Entire Ramp.

R304.5.3, STD 1115

Total Cost: \$ 3080
