# Access Compliance Report Public Rights-of-Way (Curb Ramps)

Main Street: ADDISON\_RD Cross Street: CORONEL\_RD Location: SW

ADA ID: RPRK211013123602 Ramp Type: Type 6 - Directional 1 Initial Pass/Fail: Pass Overall Compliance: No Severity Score: 15

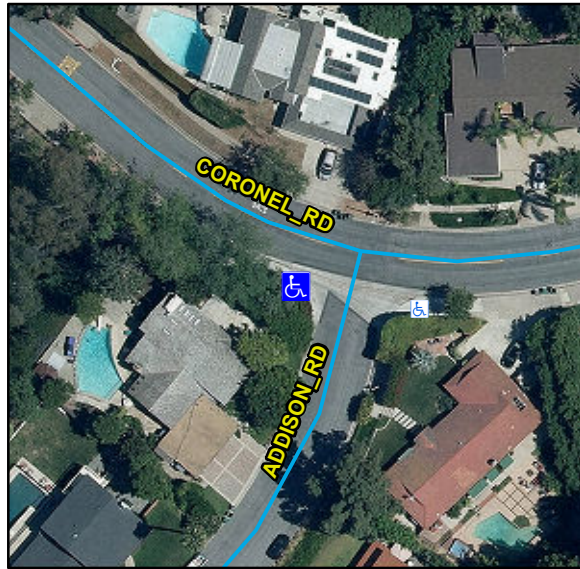
| Compliance | Description | Data | Compliance | Description | Data |
|---|---|---|---|---|---|
| No | Grade Break Slope (%) | 5.8 | | | Curbed1 |
| No | Landing Run Slope (%) | 6.6 | | DWS Offset Type | N/A |
| No | Gutter Cross Slope (%) | 8.2 | | Parallel Ramp Side | N/A |

Remove & Replace Entire Ramp. Remove & Replace Gutter.

R304.2.2-Perp, R304.3.2-Para, R304.5.3, R304.2.3, R305, STD 1115
