# Access Compliance Report Public Rights-of-Way (Curb Ramps)

Main Street: BIMINI\_DR Cross Street: HYDE PARK\_DR Location: NW

ADA ID: RPRK211013130109 Ramp Type: Type 4 - Parallel Initial Pass/Fail: Fail Overall Compliance: No Severity Score: 15

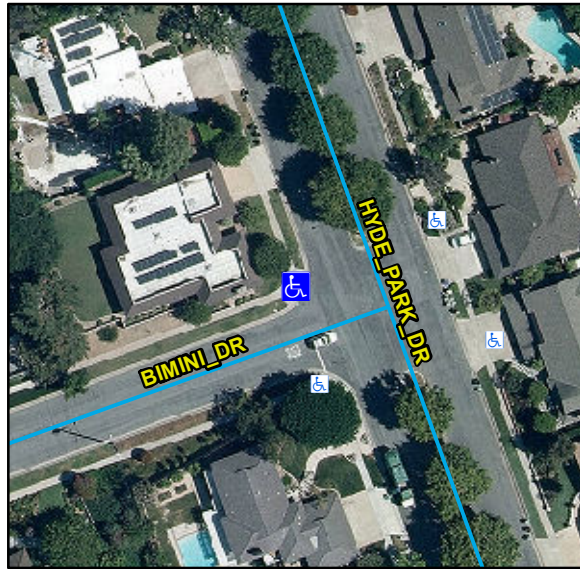
| Compliance | Description | Data | Compliance | Description | Data |
|---|---|---|---|---|---|
| No | Ramp Cross Slope LT (%) | 6.6 | No | Ramp Cross Slope RT (%) | 4.9 |

**Remove & Replace Curb Ramp With Two New Directional Ramps or Equivalent.**

**R204.3, R304.5.3, STD 1115**
