# Access Compliance Report Public Rights-of-Way (Curb Ramps)

Main Street: HYDE\_PARK\_DR Cross Street: BIMINI\_DR Location: SW

ADA ID: RPRK211013130333 Ramp Type: Type 4 - Parallel Initial Pass/Fail: Fail Overall Compliance: No Severity Score: 15

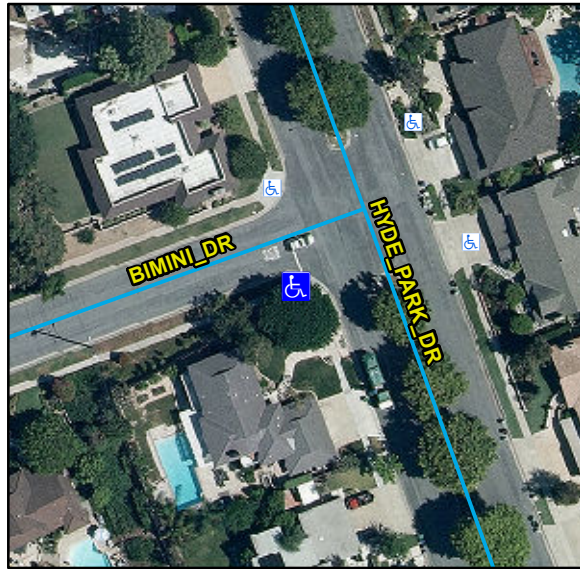
| Compliance | Description | Data | Compliance | Description | Data |
|---|---|---|---|---|---|
| No | Ramp Cross Slope LT (%) | 3.1 | No | Ramp Cross Slope RT (%) | 6.1 |

**Remove & Replace Curb Ramp With Two New Directional Ramps or Equivalent.**

**R204.3, R304.5.3, STD 1115**
