# Access Compliance Report Public Rights-of-Way (Curb Ramps)

Main Street: DORSETSHIRE\_LN Cross Street: BIMINI\_DR Location: NE

ADA ID: RPRK211013130738 Ramp Type: Type 1 - Perpendicular Diagonal Initial Pass/Fail: Fail Overall Compliance: No Severity Score: 2

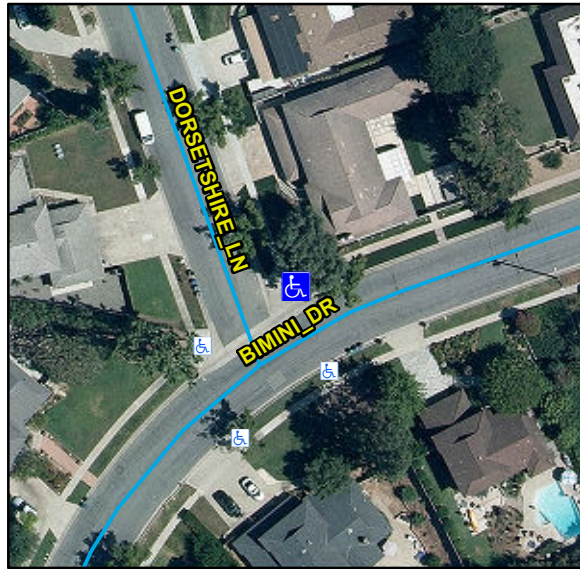
| Compliance | Description | Data | Compliance | Description | Data |
|---|---|---|---|---|---|
| No | Ramp Cross Slope (%) | 3.1 | N/A | Flare Traversable LT | N/A |

**Remove & Replace Curb Ramp With Two New Directional Ramps or Equivalent.**

**R304.5.3, STD 1115**
