# Access Compliance Report Public Rights-of-Way (Curb Ramps)

Main Street: BIMINI\_DR Cross Street: DORSETSHIRE\_LN Location: NW

ADA ID: RPRK211013130922 Ramp Type: Type 4 - Parallel Initial Pass/Fail: Fail Overall Compliance: No Severity Score: 30

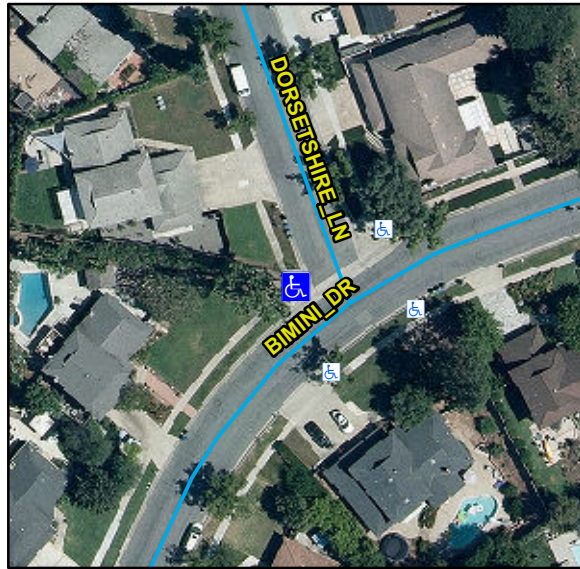
| Compliance | Description | Data | Compliance | Description | Data |
|---|---|---|---|---|---|
| Yes | Ramp Run Slope LT (%) | 4.6 | Yes | Ramp Run Slope RT (%) | 8.2 |
| No | Ramp Cross Slope LT (%) | 8.8 | No | Ramp Cross Slope RT (%) | 4.6 |

Remove & Replace Curb Ramp With Two New Directional Ramps or Equivalent.

R204.3, R304.5.3, STD 1115
