# Access Compliance Report Public Rights-of-Way (Curb Ramps)

Main Street: BIMINI\_DR Cross Street: CAMBERA\_LN Location: SE

ADA ID: RPRK211013131428 Ramp Type: Type 1 - Perpendicular Diagonal Initial Pass/Fail: Pass Overall Compliance: No Severity Score: 20

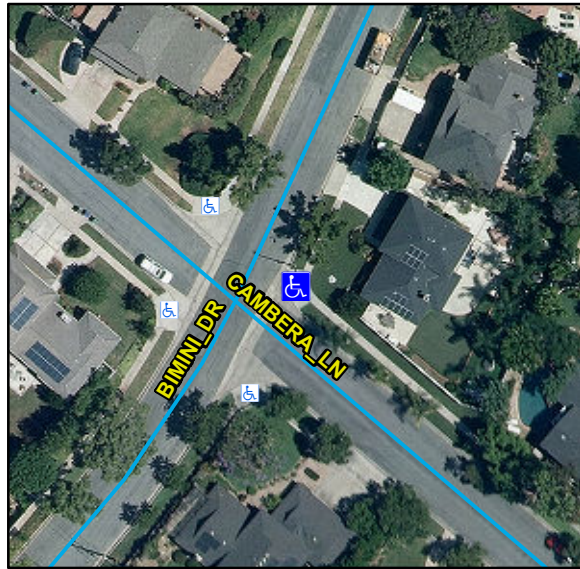
| Compliance | Description | Data | Compliance | Description | Data |
|---|---|---|---|---|---|
| No | Landing Width (in) | N/A | N/A | Flare Slope RT (%) | 4 |
| No | Landing Run Slope (%) | N/A | N/A | Flare Traversable RT | No |
| No | Landing Cross Slope (%) | N/A | No | DWS Provided | No |

Remove & Replace Curb Ramp With Two New Directional Ramps or Equivalent.

R204.3, R304.2.1, R304.2.2-Perp, R304.3.2-Para, R304.5.3, R305, STD 1115
