# Access Compliance Report Public Rights-of-Way (Curb Ramps)

Main Street: CAMBERA\_LN Cross Street: BIMINI\_DR Location: SW

ADA ID: RPRK211013132026 Ramp Type: Type 1 - Perpendicular Diagonal Initial Pass/Fail: Pass Overall Compliance: No Severity Score: 22

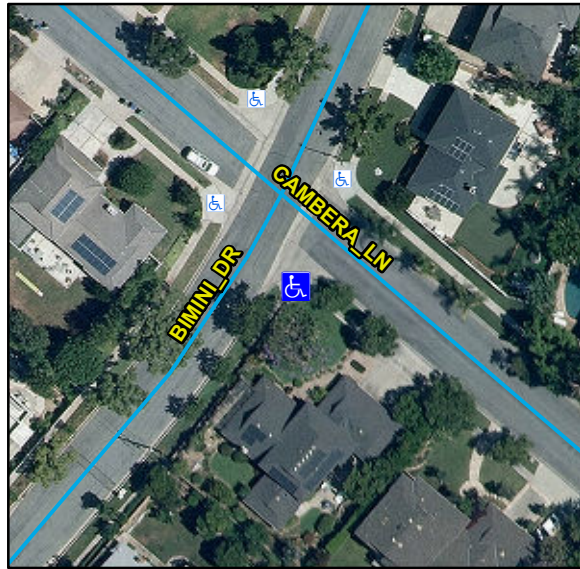
R204.3, R304.2.1, R304.2.2-Perp, R304.3.2-Para, R304.5.3, R305, STD 1115

Remove & Replace Curb Ramp With Two New Directional Ramps or Equivalent.
