# Access Compliance Report

## Public Rights-of-Way

### (Curb Ramps)

Main Street: BIMINI\_DR Cross Street: CAMBERA\_LN Location: W

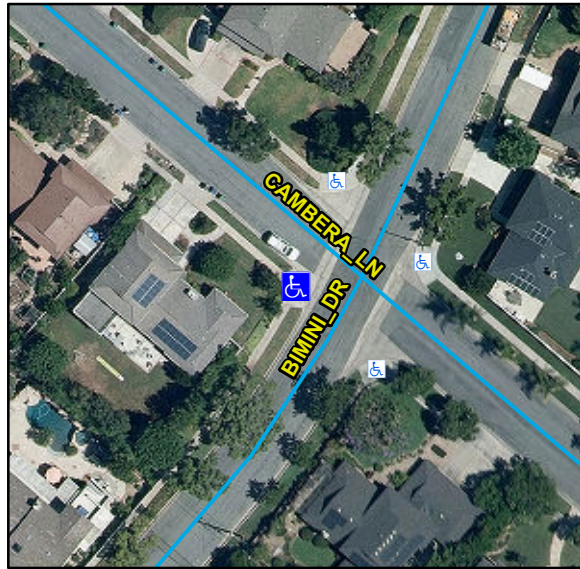
ADA ID: RPRK211013132356 Ramp Type: Type 1 - Perpendicular Diagonal Initial Pass/Fail: Pass Overall Compliance: No Severity Score: 22

| Compliance | Description | Data | Compliance | Description | Data |
|---|---|---|---|---|---|
| No | Ramp Cross Slope (%) | 2.6 | N/A | Flare Traversable LT | No |
| No | Landing Width (in) | N/A | N/A | Flare Slope RT (%) | 0.7 |
| No | Landing Run Slope (%) | N/A | N/A | Flare Traversable RT | No |
| No | Landing Cross Slope (%) | N/A | No | DWS Provided | No |

**Remove & Replace Curb Ramp With Two New Directional Ramps or Equivalent.**
