# Access Compliance Report Public Rights-of-Way (Curb Ramps)

Main Street: CAMBERA\_LN Cross Street: FENWICK\_PL Location: N

ADA ID: RPRK211013132847 Ramp Type: Type 1 - Perpendicular Diagonal Initial Pass/Fail: Fail Overall Compliance: No Severity Score: 2

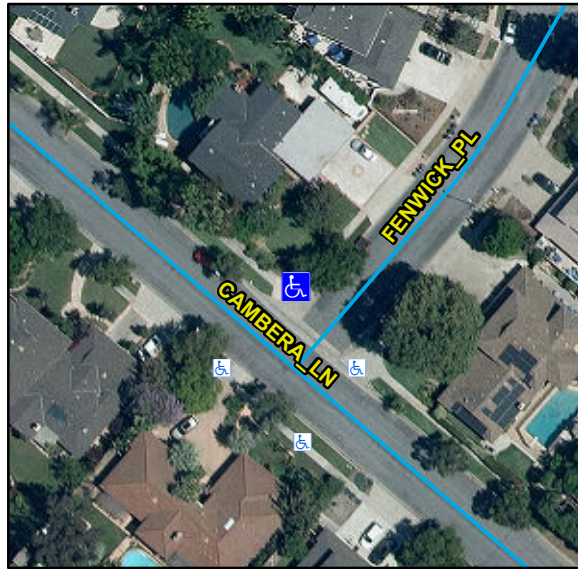
| Compliance | Description | Data | Compliance | Description | Data |
|---|---|---|---|---|---|
| No | Ramp Cross Slope (%) | 3.8 | N/A | Flare Traversable LT | N/A |

Remove & Replace Curb Ramp With Two New Directional Ramps or Equivalent.

R304.5.3, STD 1115
